Road Safety Audit

**SR 306 (Reynolds Road)
and
US 20 (Mentor Avenue)
Intersection
City of Mentor, Ohio**

May 2009

**Prepared By
Northeast Ohio Areawide
Coordinating Agency
1299 Superior Avenue
Cleveland Ohio 44114**

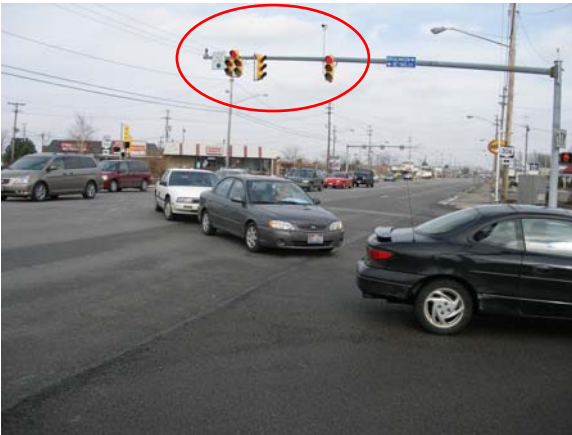
Westbound traffic on US20, turning left onto SR306 southbound during the green interval of the exclusive left turn phase, slows down due to congestion downstream on SR306 southbound

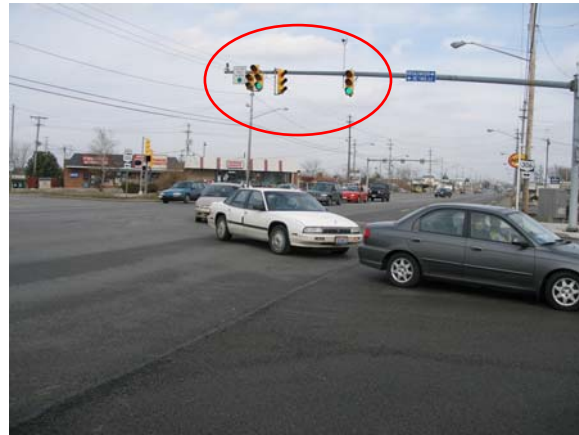
Residual westbound traffic on US20 turning left onto SR306 southbound trapped within the intersection during the green interval for east-west traffic movements due to congestion on the southern leg of SR306

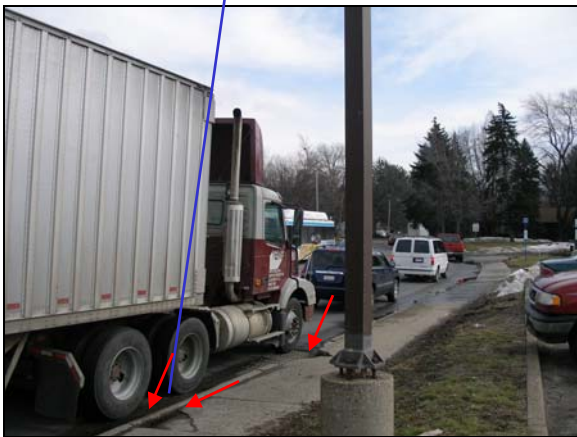
Road is narrow. Sidewalk is cracked, narrow, and soiled

Congestion on narrow, single-lane south-bound SR306 (Broadmoor) south of US20, looking south

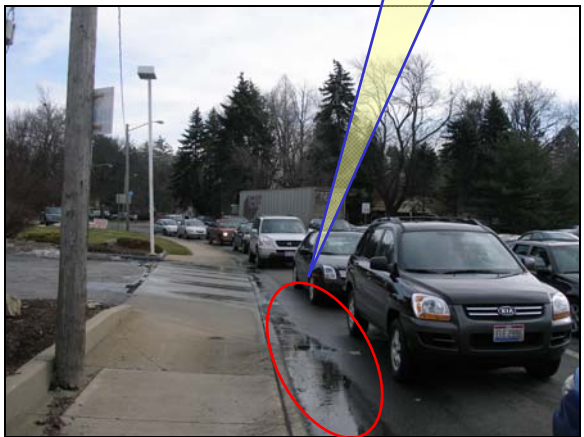
Standing water avoided by drivers

Northbound SR306, south of US20, looking south

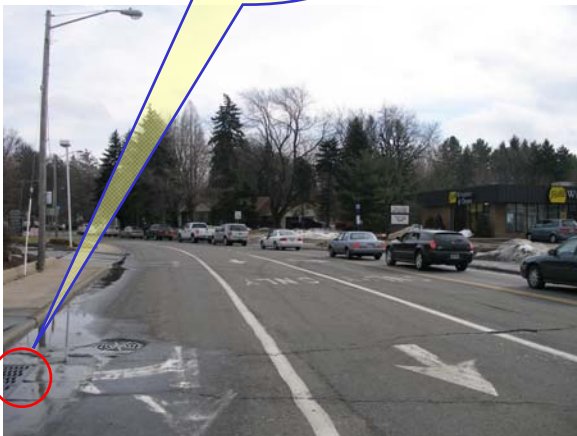
Storm water catch basin

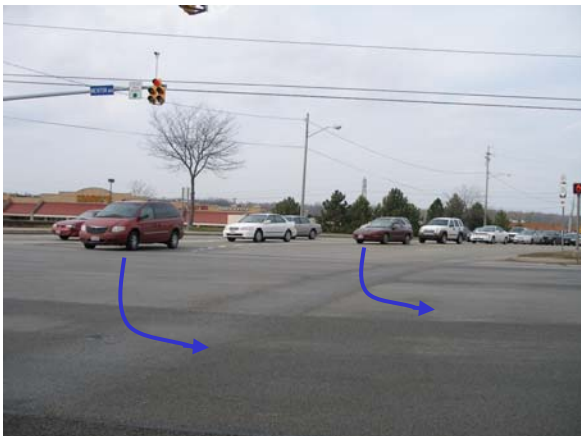
Southbound approach of SR306 showing the double left-turn lanes. A new pavement has recently been laid. Lane guide markings need to be placed.

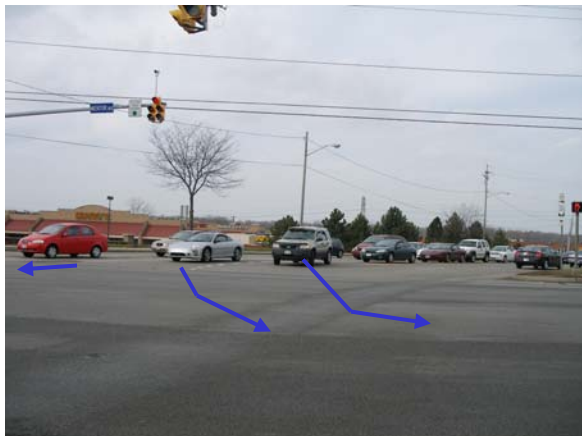
Absent are lane guide markings within the intersection to guide the double left turning movements from the SR306 southbound approach to US20 eastbound

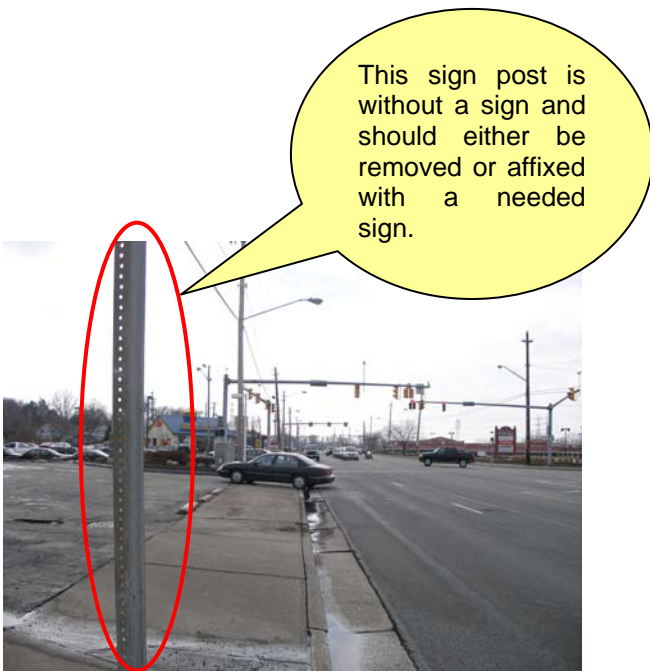
- A post without a traffic regulating sign. A heavily soiled sidewalk, not conducive to safe or pleasant pedestrian experience

This sign post is without a sign and should either be removed or affixed with a needed sign.

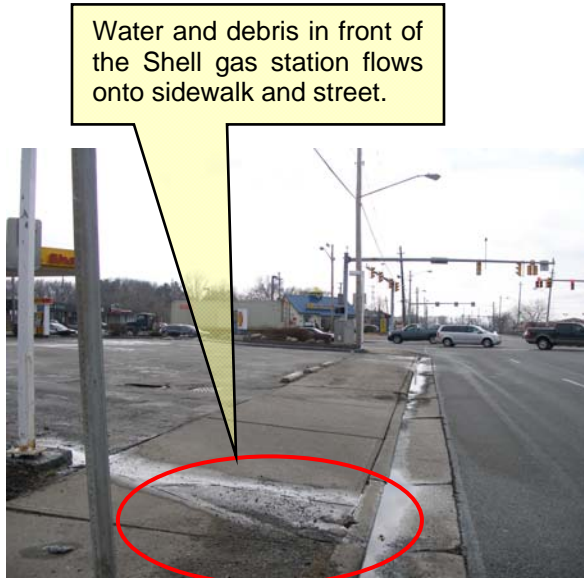
Water and debris in front of the Shell gas station flows onto sidewalk and street.

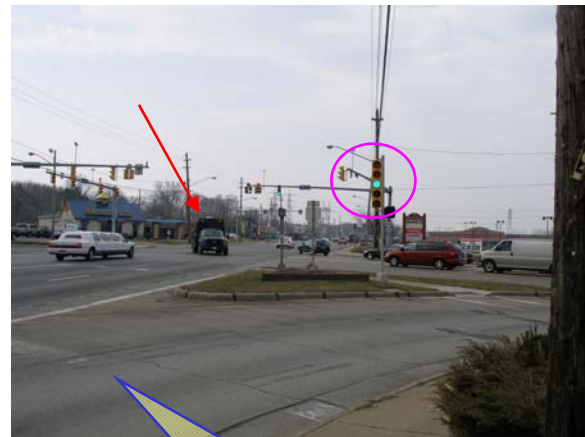
Faded Stop Line

Stop Line is faded, and placed too far from edge of intersection with the main road

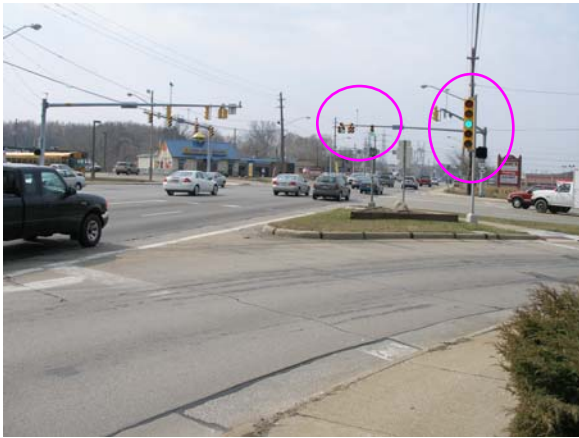
The pole-mounted signals, intended for the channelized right-turn lane, and the mast-mounted signals, intended for the through and left-turn lanes, operate in tandem causing the production of conflicting signal indications, shown in the photos below.

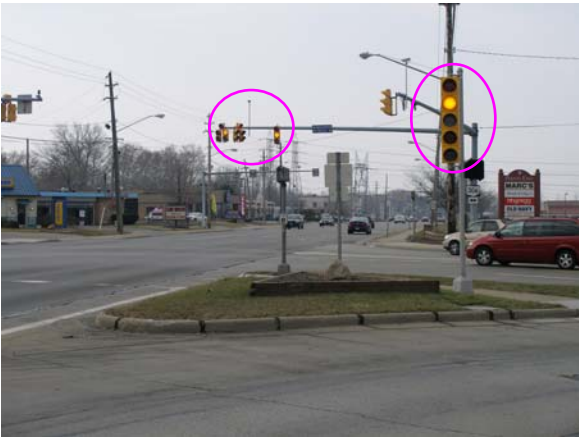
The pole-mounted signals, intended for the channelized right-turn lane, and the mast-mounted signals, intended for the through and left-turn lanes, operate in tandem causing the production of conflicting signal indications, shown in the photos below.

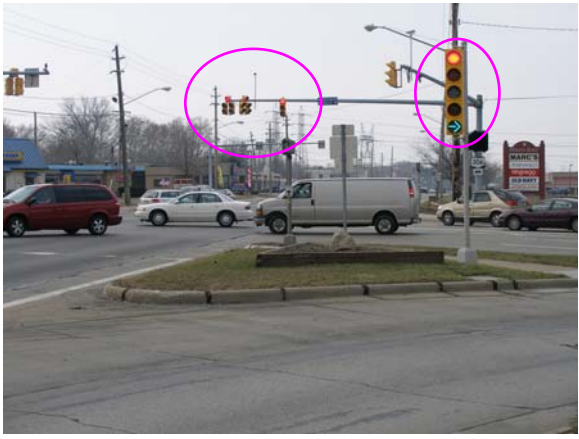
The pole-mounted signals, intended for the channelized right-turn lane, and the mast-mounted signals, intended for the through and left-turn lanes, operate in tandem causing the production of conflicting signal indications as shown in the photo. The signal heads mounted on the pole on the right of the road across the one shown in the photo display the same indications, hence the confusion.

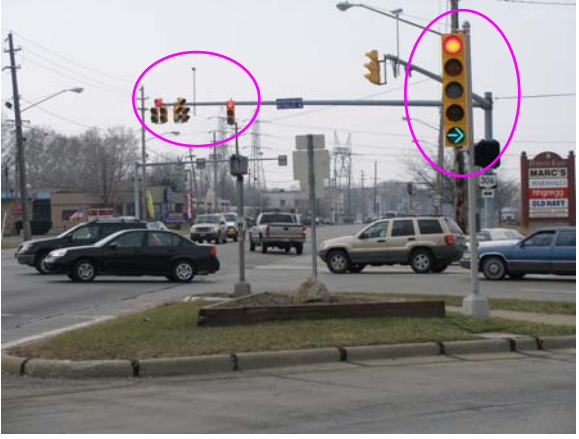
The pole-mounted signals, intended for the channelized right-turn lane, and the mast-mounted signals, intended for the through and left-turn lanes, operate in tandem causing the production of conflicting signal indications as shown in the photo. The signal heads mounted on the pole on the right of the road across the one shown in the photo display the same indications, hence the confusion.

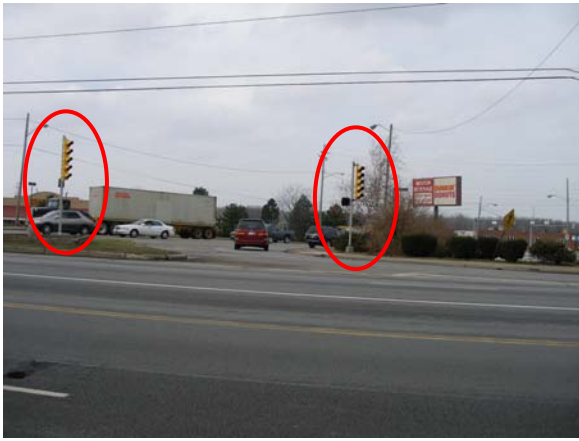
The pole-mounted traffic signal heads are intended to control traffic in the channelized right turn lane on the US20 westbound approach. They, however, operate in tandem with the signals mounted on the mast, which causes some confusion to drivers.

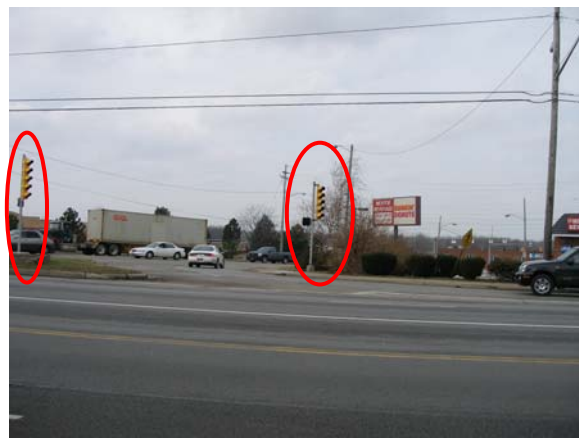
The pole-mounted traffic signal heads on the pole to the left, within the island, is intended to control traffic in the channelized lane as evidenced by its placement and location far to the right of the edge of the roadway for through traffic.

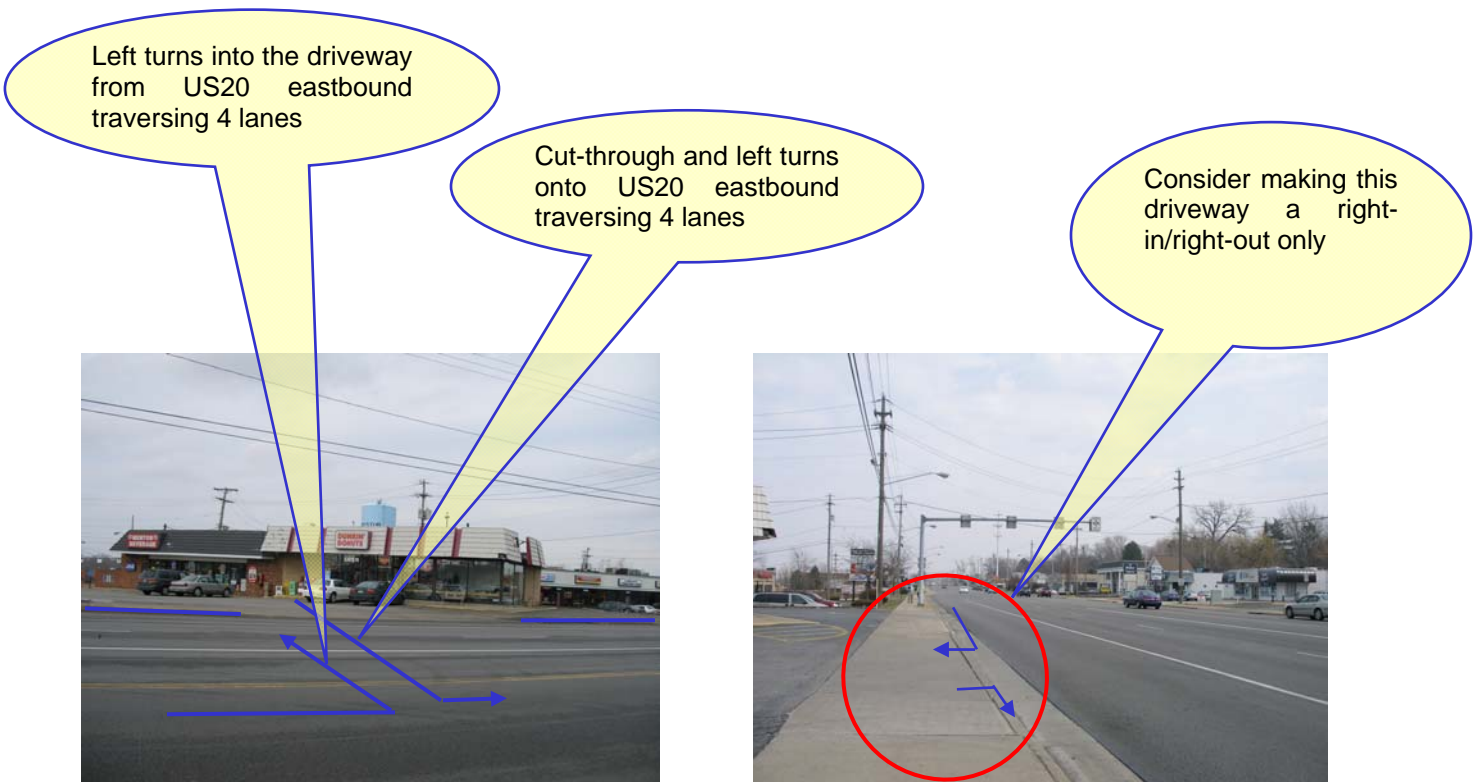
- The driveway to the retail shops in the northeast quadrant of the intersection, fronting US20 (Mentor Avenue), is sometimes used as a cut-through by violators who enter the forefront of the shops from the SR306 southbound approach through its driveway fronting northbound SR306, and exit it by turning left onto US20 eastbound. Furthermore, eastbound traffic on US20 often attempts to enter the driveway, crossing four lanes of roadway or traffic, especially during heavy traffic movements. Consider making this driveway to serve right-in/right-out only traffic movements to discourage cut-through behavior and to prevent disruption to the flow of westbound traffic on US20 when vehicles attempt to enter it by turning left from the US20 eastbound through lanes.

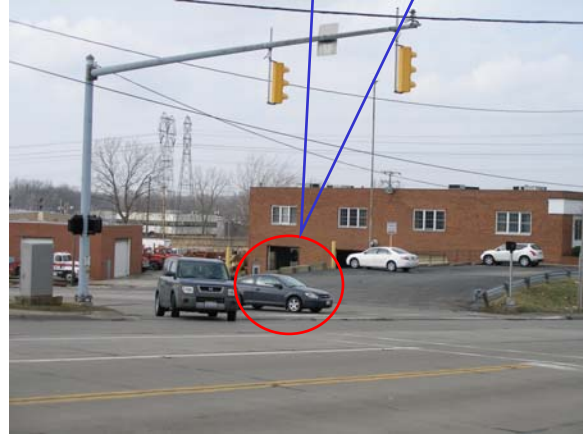
Vehicle blocks line of sight of driver in vehicle on right

Set back stop bar for this left turn bay to overcome problem of line of sight for vehicles in the right turn bay

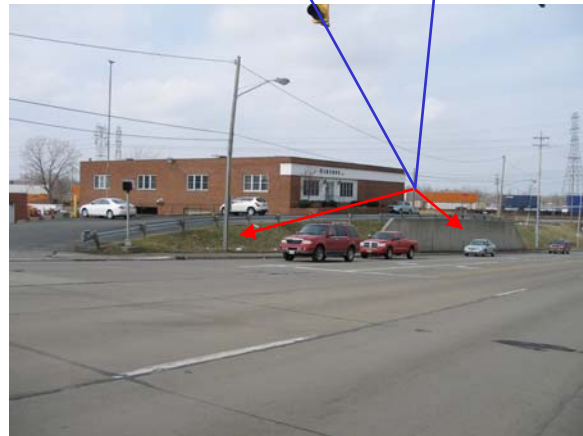
Retaining wall and embankment are irremovable obstacles to line of sight

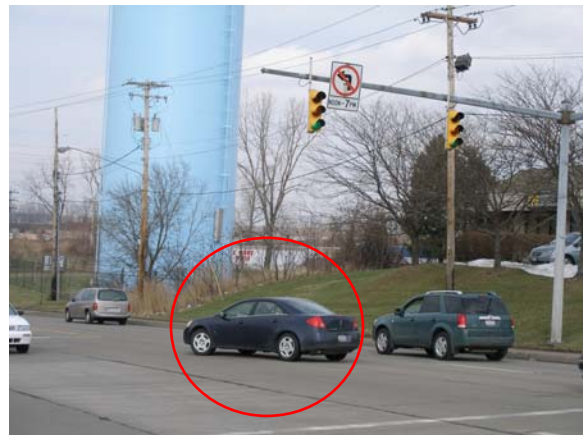
When traffic exiting the driveway of the shopping plaza on SR306 awaits the green interval, the line of vision of those who intend to turn right on red is blocked by vehicles in the left turn lane protruding beyond the stop line.

The left turn prohibition sign, affixed on the traffic signal mast overhead, is sometimes violated. Prohibition of left turns into the shopping plaza during the noon-7pm period should be maintained and enforced.

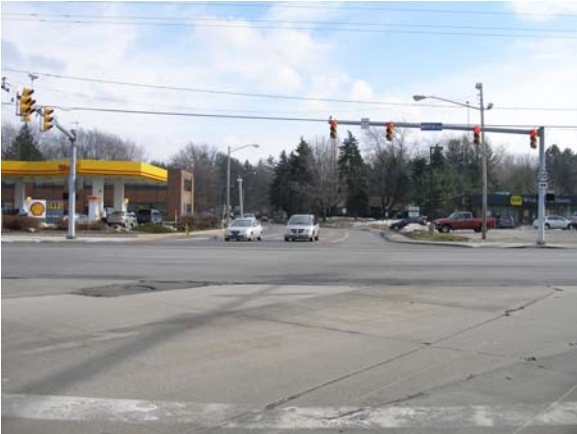
Faded/worn out lane and stop bar markings

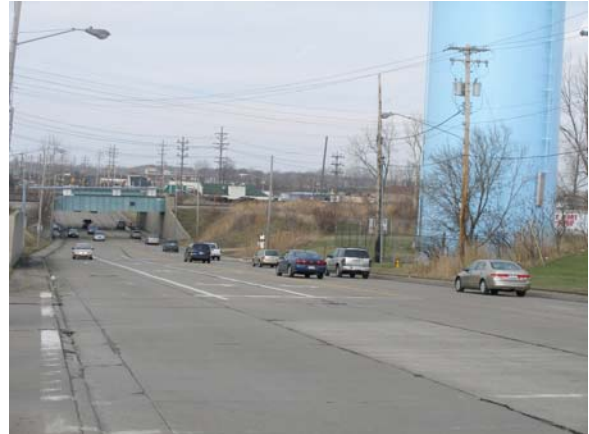
Faded/worn out lane and stop bar markings

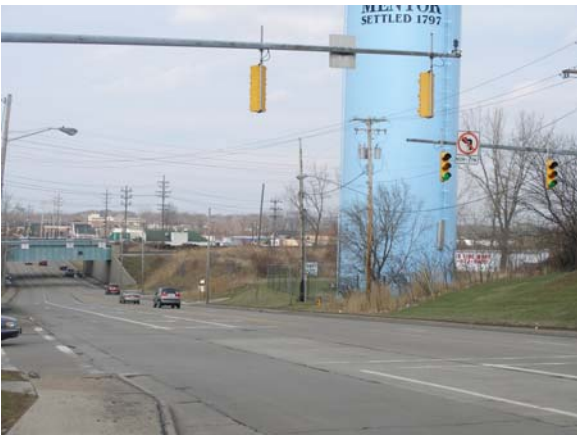
Faded/worn out lane, stop bar, and cross walk markings

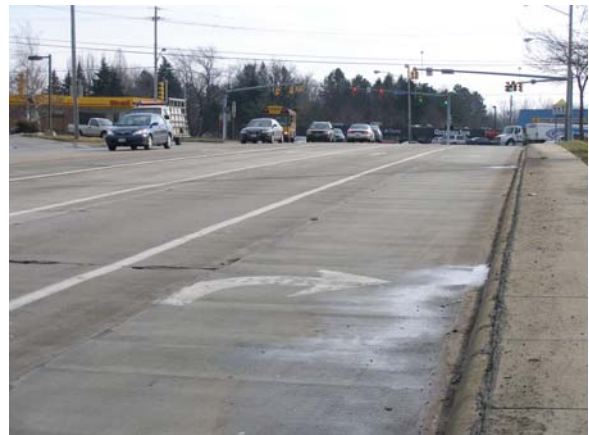
Faded/worn out lane markings and lane assignment arrows

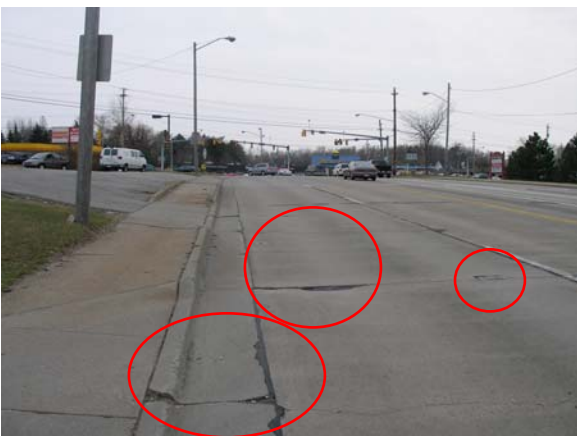
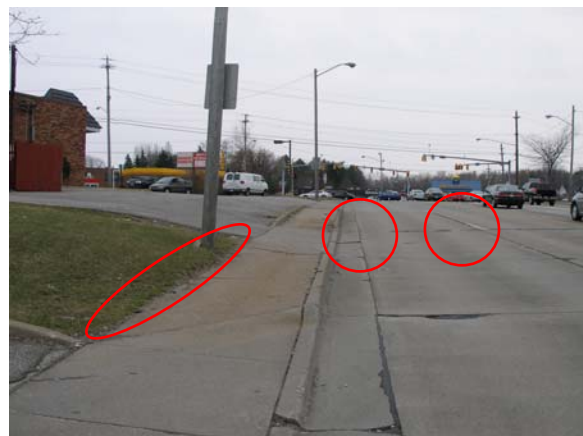
- Surface conditions are less than desirable. Cracked pavement and sidewalks, debris on pavement and sidewalks, and broken curbs were noticed.

Debris and cracked concrete sidewalks and aprons

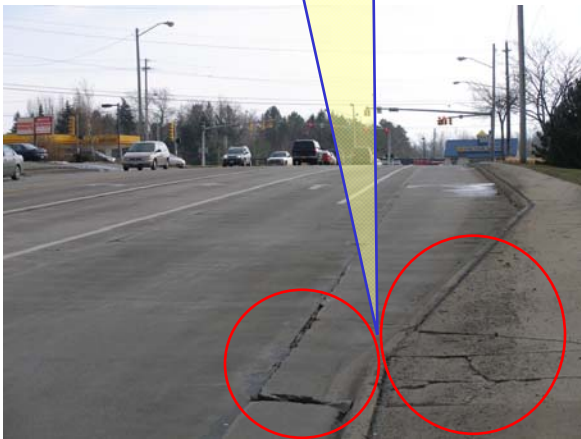
Cracks in pavement

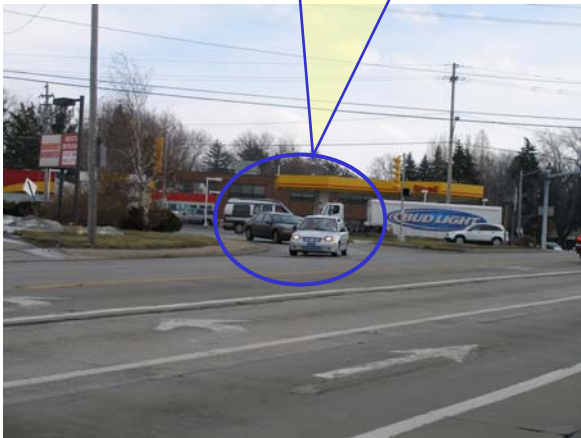
Vehicles in the channelized right turn lane past the pole-mounted signal heads

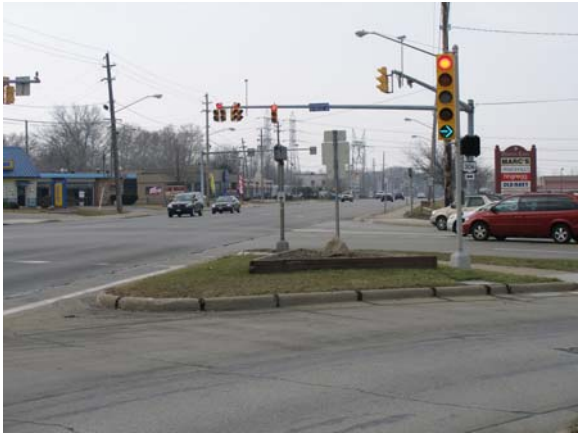
Signal indications on the pole-mounted signal heads, intended to control traffic in the channelized right turn lane, display conflicting indications

To some drivers it could be obvious but to others it sends a conflicting message, which causes second thinking and hesitation. Traffic control indications must be clear and intuitive. Obviously, in this case it is not.

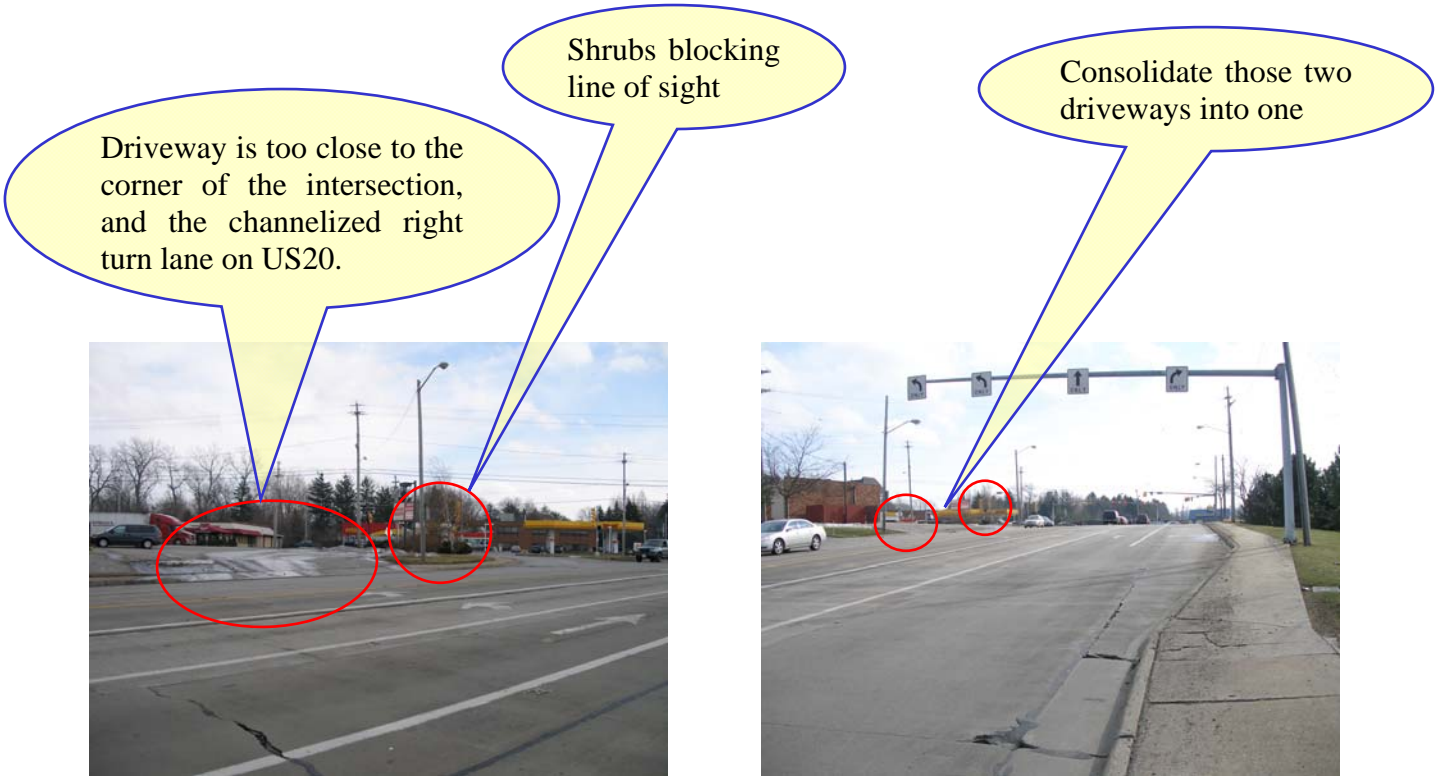
- There are two driveways for the shops in this shopping strip. They can be consolidated and replaced with one driveway to be located farther away from the corner of the intersection.

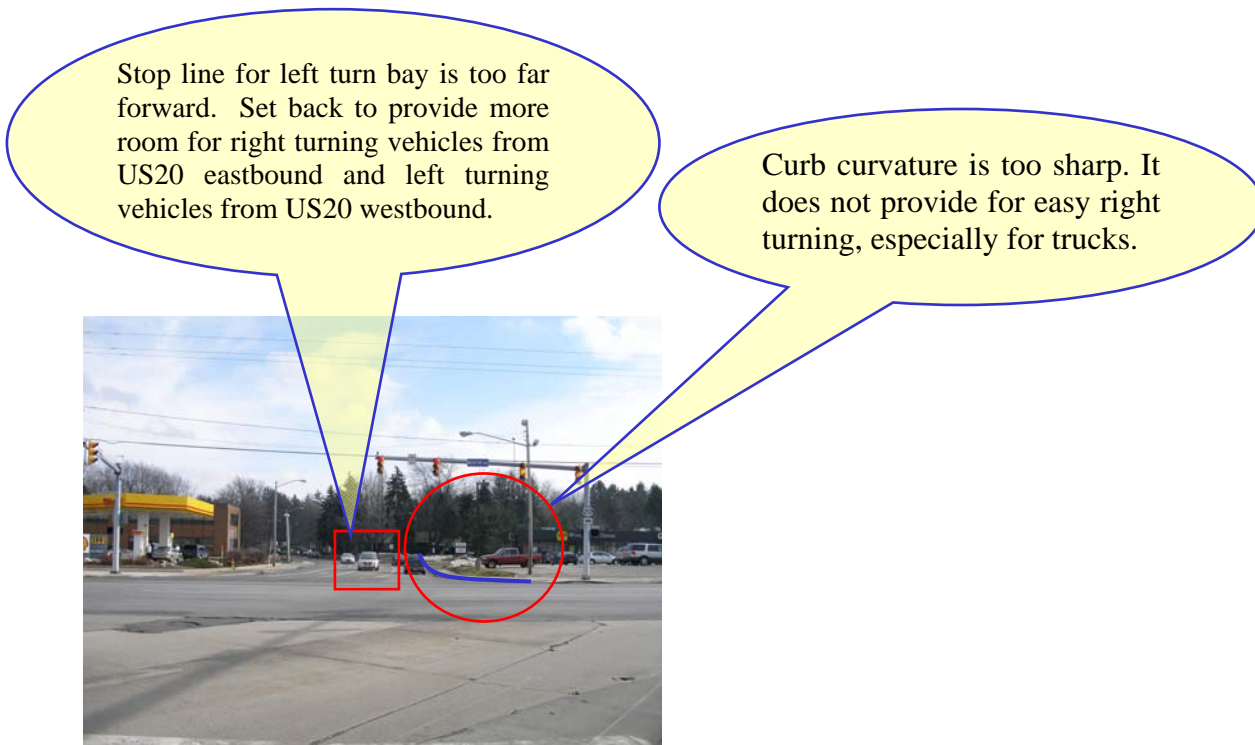
- The stop line for the left turn bay on the northbound approach of SR306 should be offset or staggered from the stop line for the through bay to provide room for southbound left and right turning traffic from US20. The curb curvature on the southwest quadrant should be increased.

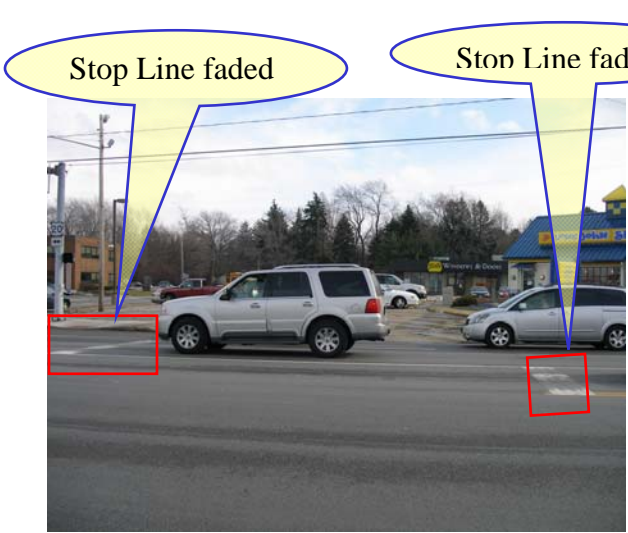
US20 eastbound, stop line markings, faded

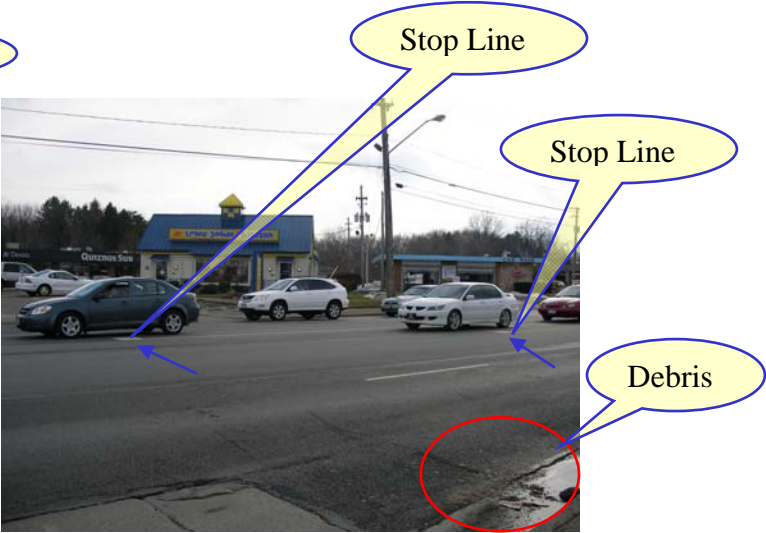
US20 eastbound, stop line markings, faded

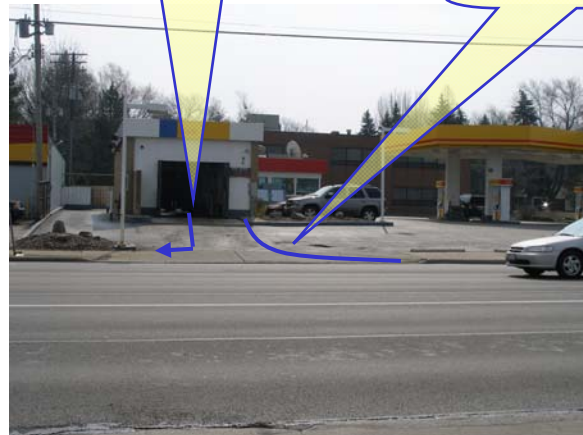
Overall view of the Shell gas station driveways and curbs along US20

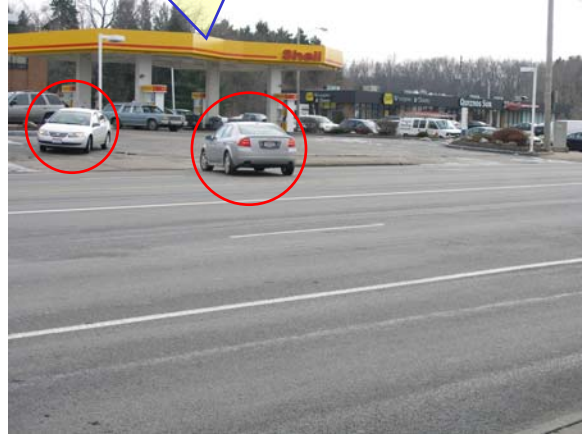
Misalignment of vehicle exit and entry points into gas station due to the misalignment of driveways with the positions and orientation of the gas pumps.

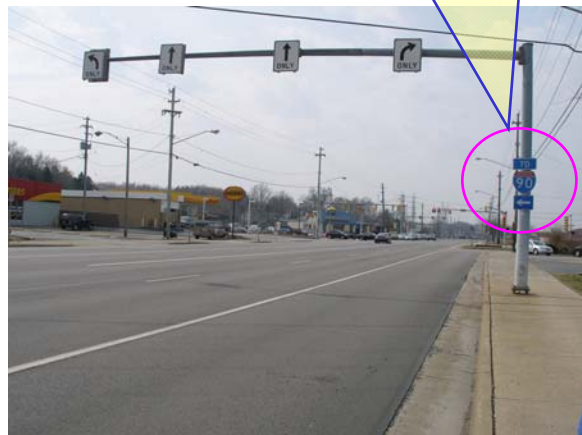
- Signage to I-90 is inconspicuous and small. It is placed on the mast pole on the far right of the roadway, but potential users need to see it well in advance and expect to find it placed overhead as traffic bound for I-90 will be or should be advised in advance to be in the left lane. Using guide signs specified in the Ohio Manual of Traffic Control Devices (OMUTCD) would be helpful to Mall shoppers and visitors who may not be familiar with area.

Sign pointing to I-90 is placed too far to the right and may not always be seen by drivers, especially when trucks or tall vehicles occupy the channelized right turn lane.

Place the I-90 information sign overhead on mast.

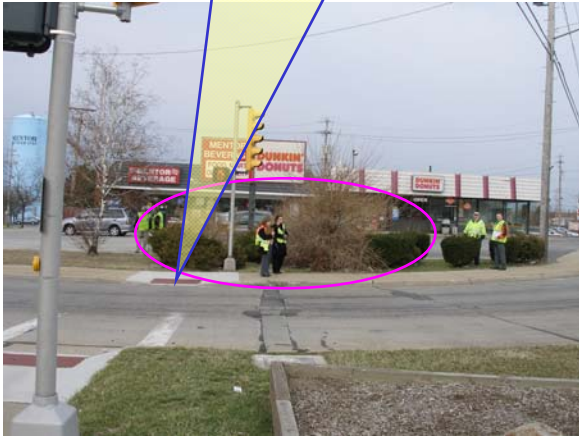
Pedestrians standing here to cross cannot see or be seen well in advance of oncoming traffic in the channelized right turn lane because of the shrubs.

- Hazardous location for pedestrian crossing due to shrubs, island location, and lane configuration. Visibility should be afforded to pedestrians and drivers to afford all the opportunity to ensure that their actions would be safe.

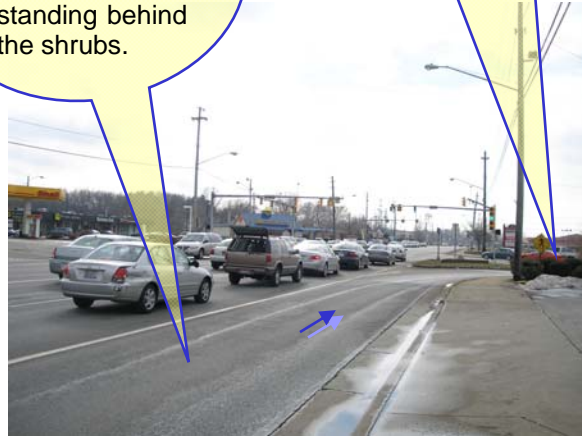
Drivers in this lane cannot see pedestrians standing behind the shrubs.

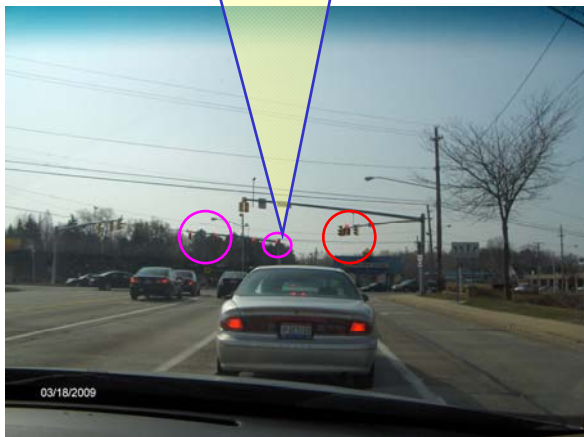
This auxiliary signal head, intended to augment another one for the single southbound through lane of the SR306 leg south of US20 is not needed, as it might mislead drivers to think there are two through lanes.

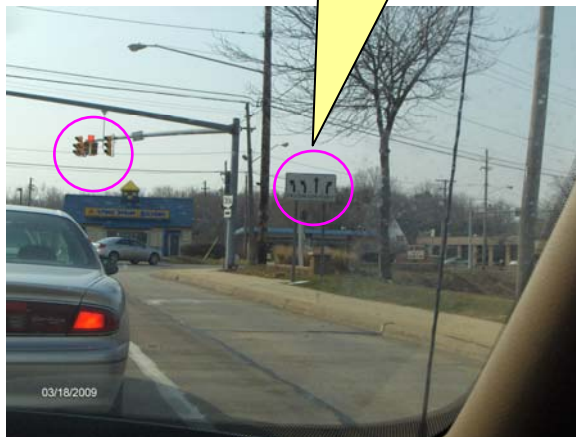
Lane assignment sign is located too far to the right and far beyond where needed to be seen by drivers.
