Road Safety Audit

**Lee Road and
Harvard Avenue
Intersection
City of Cleveland, Ohio**

April 2009

**Prepared By
Northeast Ohio Areawide
Coordinating Agency
1299 Superior Avenue
Cleveland Ohio 44114**

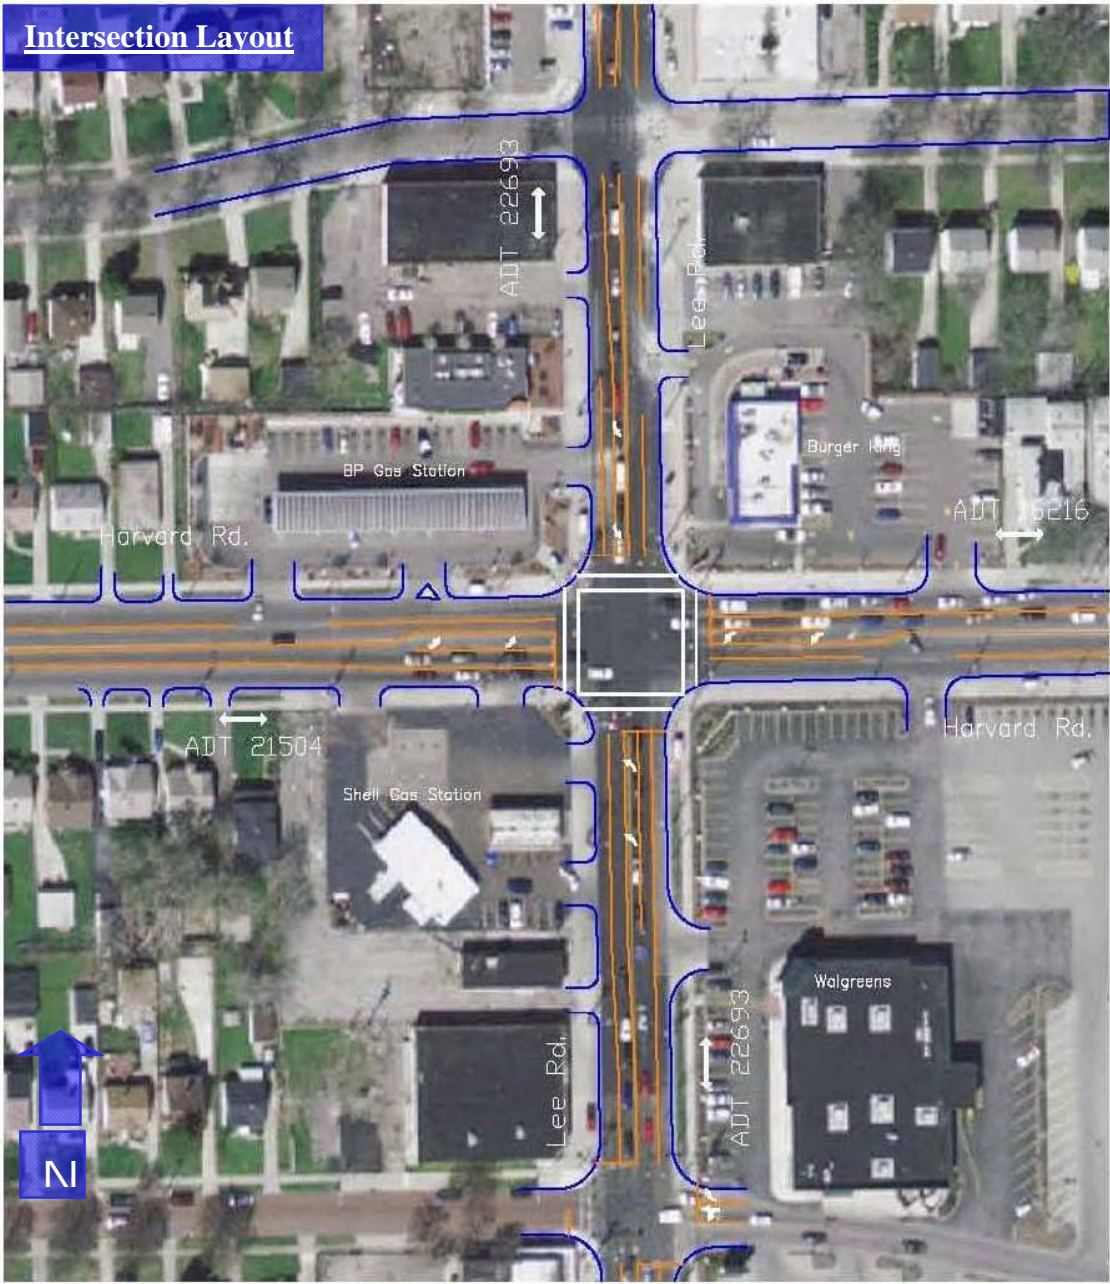
All commercial establishments have multiple access driveways in proximity of the intersection. The area is heavily travelled with average daily traffic of about 23,000 vehicles per day (VPD) on Lee Road and about 21,000 vehicles per day (VPD) on Harvard Avenue, noted on the aerial photograph shown below.

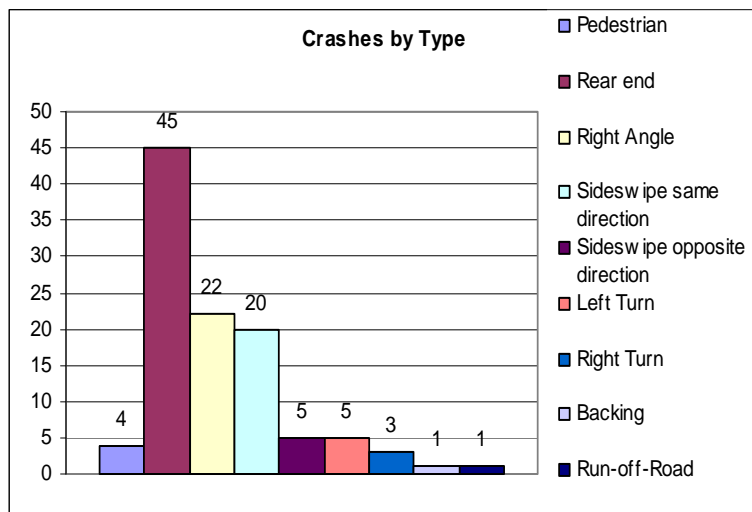
Figure 1

It is evident from the following bar charts that the predominant type of crash among the various types of crashes is the rear end collision. This signifies that there may be a high number of abrupt or sudden stops or slowdowns, unpredictable by other drivers that cause trailing vehicles to collide with vehicles in front of them. Field observations reveal that these sudden stops are mainly due to the following actions:

Collision Type	No. of Crashes
Pedestrian	4
Rear end	45
Right Angle	22
Sideswipe same direction	20
Sideswipe opposite direction	5
Left Turn	5
Right Turn	3
Backing	1
Run-off-Road	1
Total	106

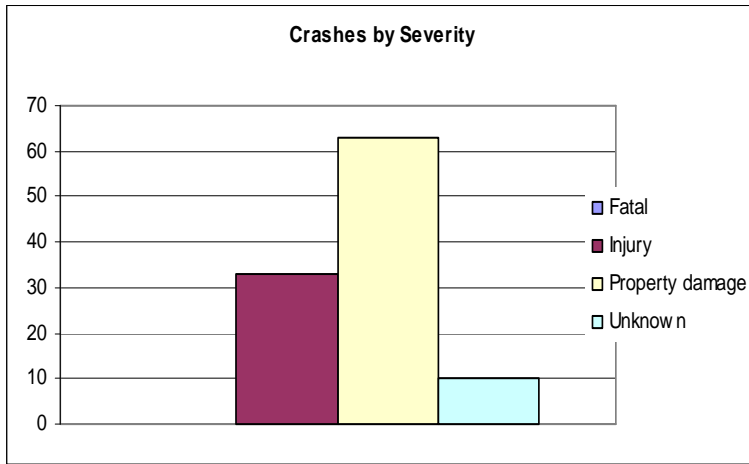
Figure 2

Crash Severity	No. of Crashes
Fatal	0
Injury	33
Property damage	63
Unknown	10
Total	106

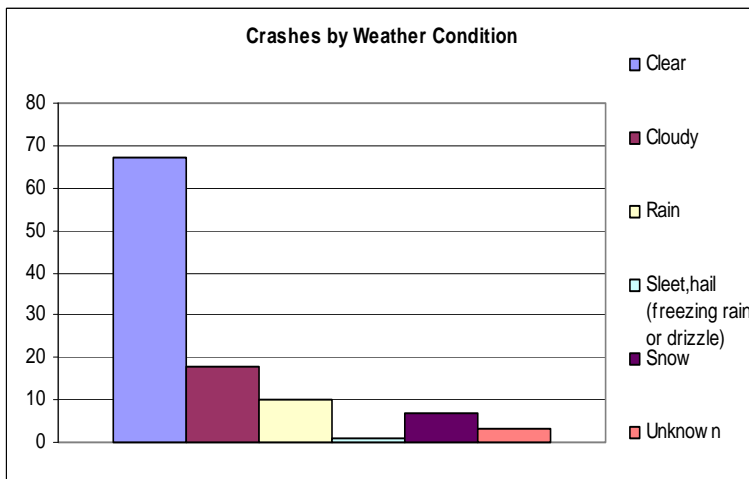
Figure 3

Weather	No. of Crashes
Clear	67
Cloudy	18
Rain	10
Sleet or hail (freezing rain or drizzle)	1
Snow	7
Unknown	3
Total	106

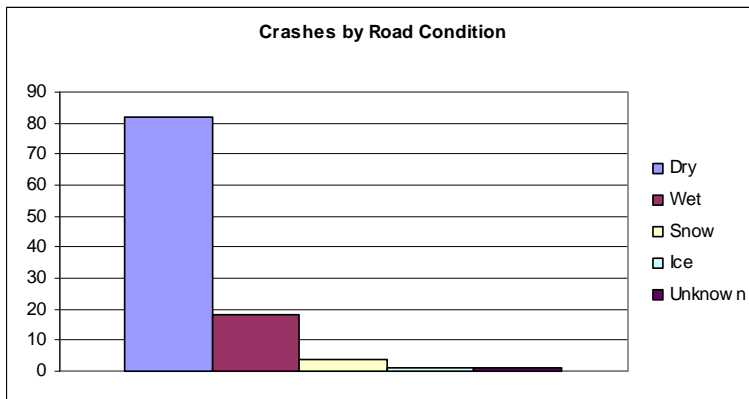
Figure 4

Crashes occur during daylight and on dry pavement conditions. This indicates that visibility and surface conditions are not contributing factors. It is, therefore, reasonable to conclude that human factors manifested by heavy traffic volumes, congestion, and uncontrolled ingress and egress points of access are primary contributing causes to these crashes.

Road Condition	No. of Crashes
Dry	82
Wet	18
Snow	4
Ice	1
Unknown	1
Total	106

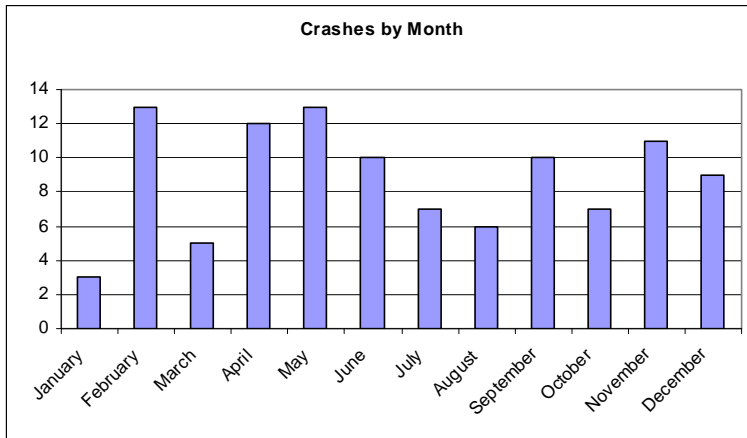
Figure 5

Month	No. of Crashes
January	3
February	13
March	5
April	12
May	13
June	10
July	7
August	6
September	10
October	7
November	11
December	9
Total	106

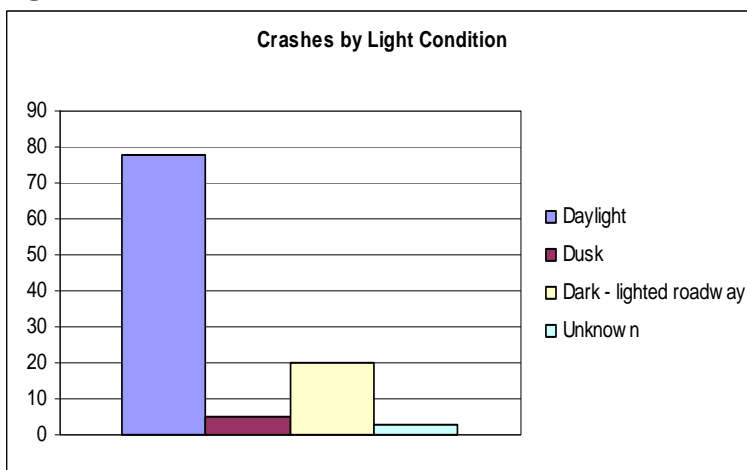
Figure 6

Light Condition	No. of Crashes
Daylight	78
Dusk	5
Dark - lighted roadway	20
Unknown	3
Total	106

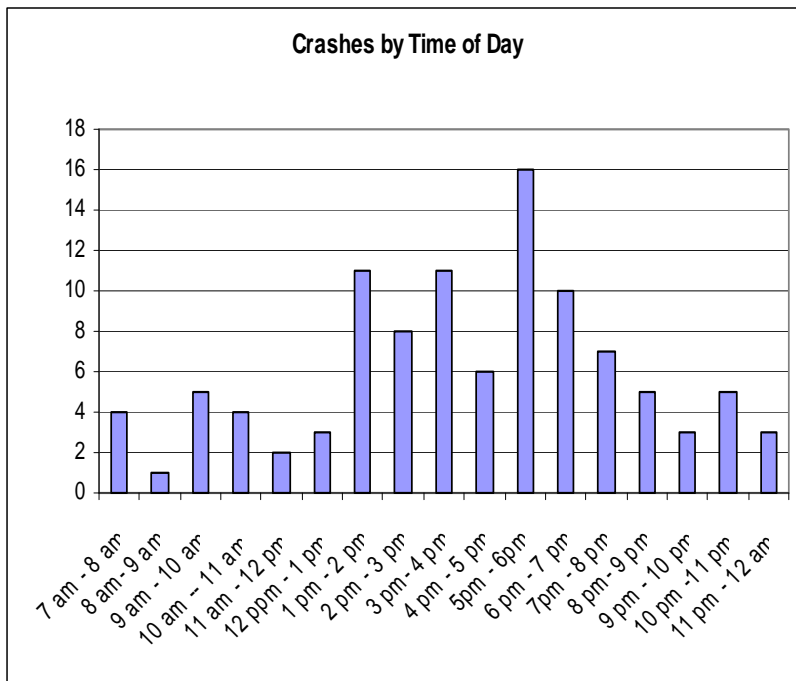
Figure 7

Time of day	No. of Crashes
12 am - 1 am	1
1 am - 2 am	1
2 am - 3 am	0
3 am - 4 am	0
4 am - 5 am	0
5 am - 6 am	0
6 am - 7 am	0
7 am - 8 am	4
8 am - 9 am	1
9 am - 10 am	5
10 am -- 11 am	4
11 am - 12 pm	2
12 pm - 1 pm	3
1 pm - 2 pm	11
2 pm - 3 pm	8
3 pm- 4 pm	11
4 pm - 5 pm	6
5 pm - 6 pm	16
6 pm - 7 pm	10
7 pm - 8 pm	7
8 pm- 9 pm	5
9 pm - 10 pm	3
10 pm -11 pm	5
11 pm - 12 am	3
Total	106

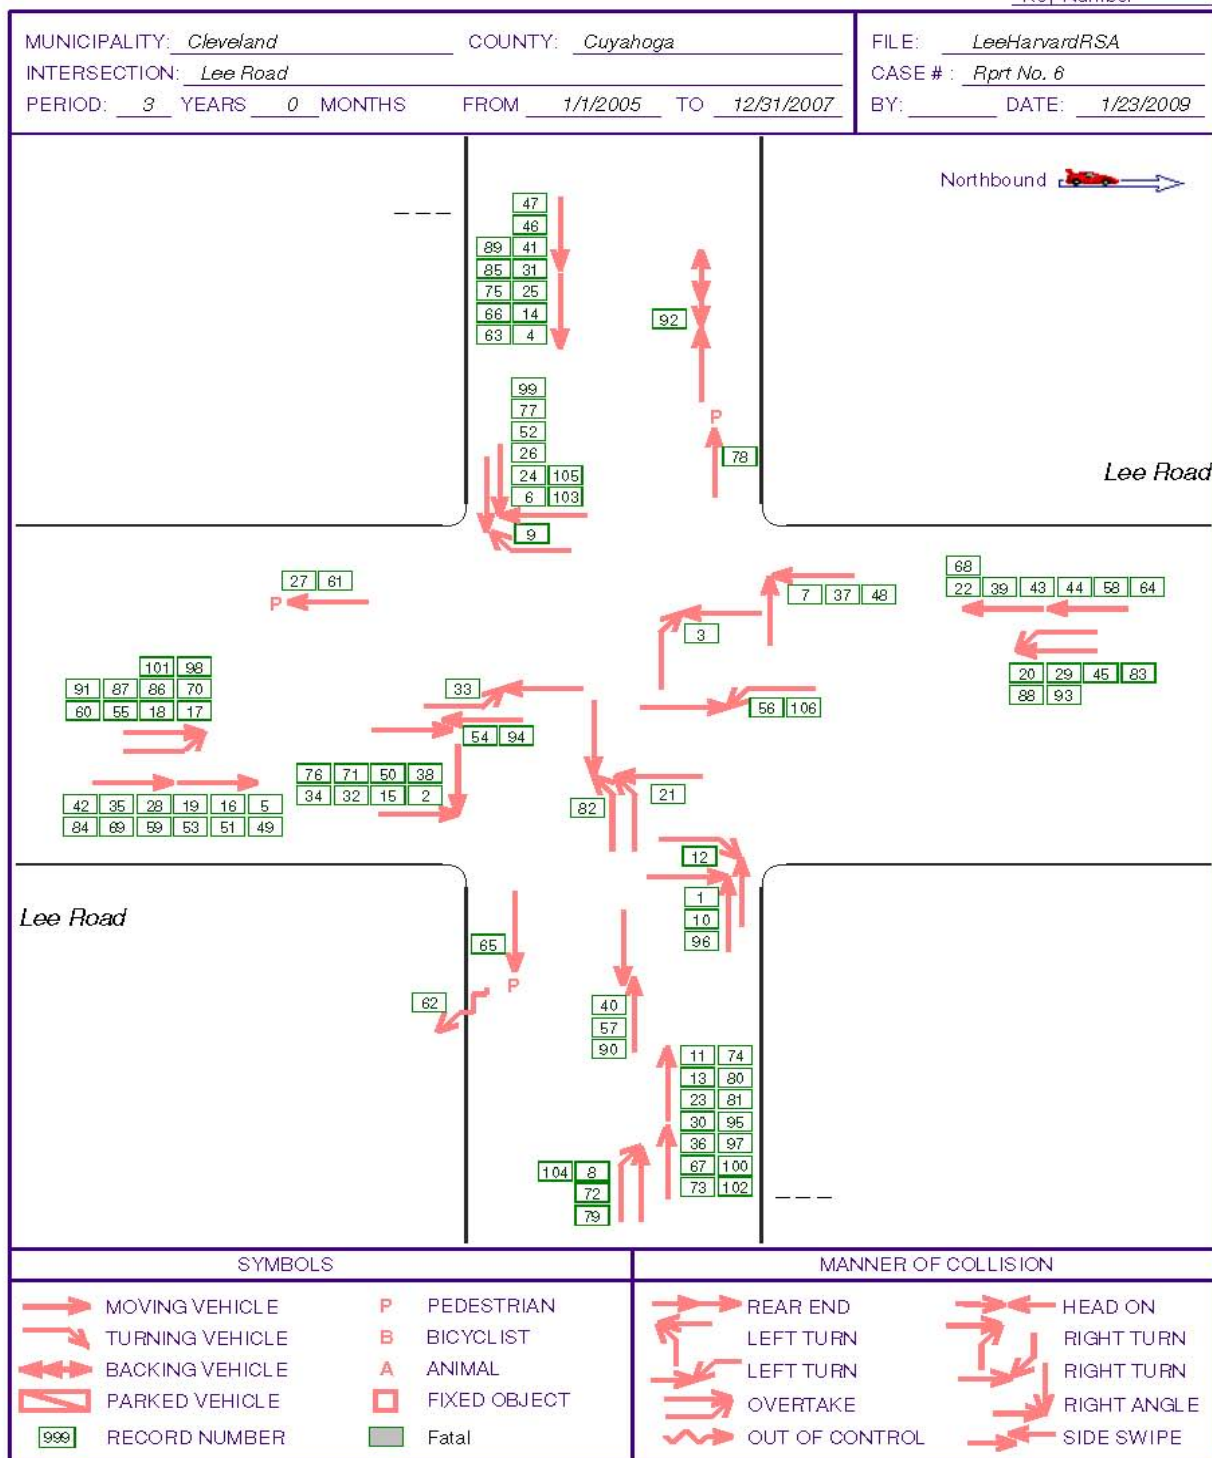
COLLISION DIAGRAM

This collision diagram depicts the type, frequency, and relative location of the crashes that occurred in the most recent 3-year period of the crash data. It is intended to further aid the reader to understand the nature of the crash problems at this intersection.

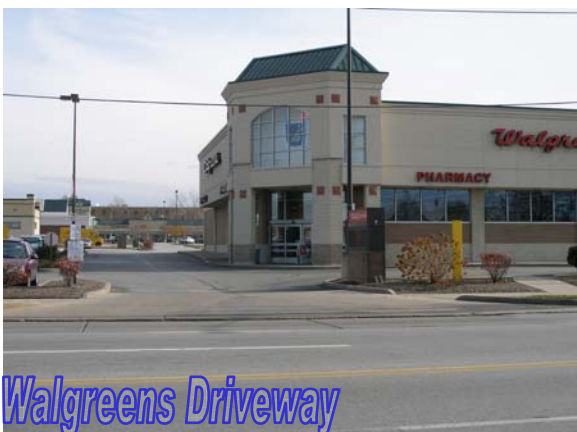
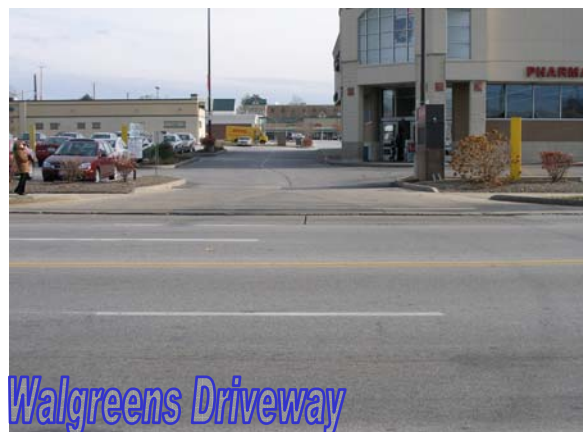
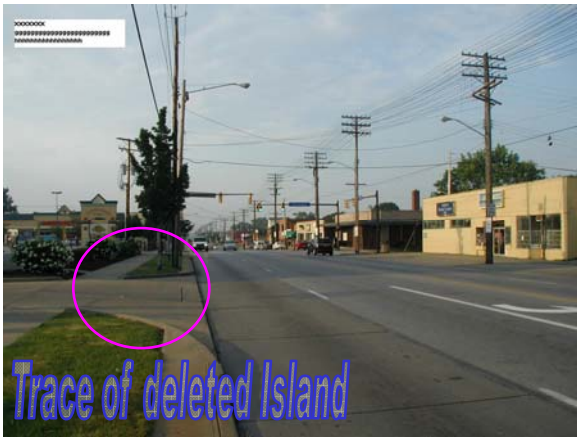
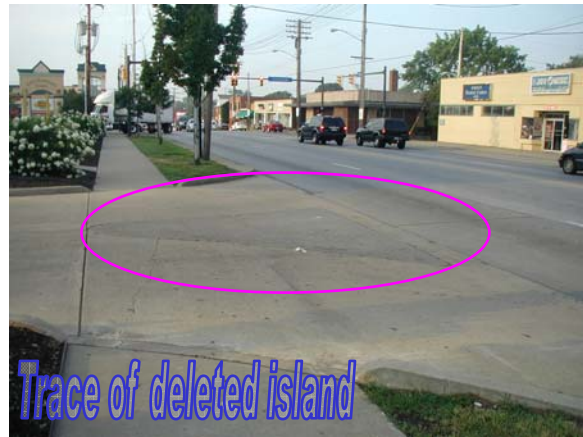
- A shopping plaza, anchored by a Walgreens drug store, exists on the eastern side of Lee Road in the south-east quadrant of the intersection. Although the plaza is serviced by two major driveways off of Lee Road and Harvard Avenue, another driveway off of Lee Road in proximity to the intersection, intended to provide additional access to service the Walgreens drug store, appears to exacerbate the already complex traffic movement conflicts and contribute to the number of crashes. The driveway, evidently, was designed to allow only right-in/right-out traffic bound for the shopping plaza. The island within the driveway that regulates the flow of traffic was deleted and traffic enters and exits the driveway in any direction. Some southbound traffic entering the shopping plaza through this driveway by turning left causes traffic conflicts, interference with traffic flow, and turbulence in traffic platoons. Exiting the driveway onto Lee Road to head in the southbound direction causes further traffic movement conflicts and interference with the ordinary flow of traffic on Lee Road in both the northbound and southbound directions. There was no evident reason as to why the island that controlled traffic movement and limited it to right-in/right-out only was removed. It might have been ignored by drivers and that resulted in problems to those who intentionally or inadvertently tried to circumvent it in their attempt to exit the driveway to head south onto Lee Road or enter the driveway when turning left onto it from Lee Road in the southbound direction. If closing the driveway altogether is not considered a reasonable option, then restoring the island is thought to be a reasonable measure to reinstate the intended control that the island provided when it was first opened.

- Examine points of access to and from (ingress and egress) the businesses near or around the intersection;
- Work with Cleveland officials and property owners to develop an access management plan for the area surrounding the subject intersection that will be conducive to reducing the number of access points, and minimize potential traffic movement conflicts;

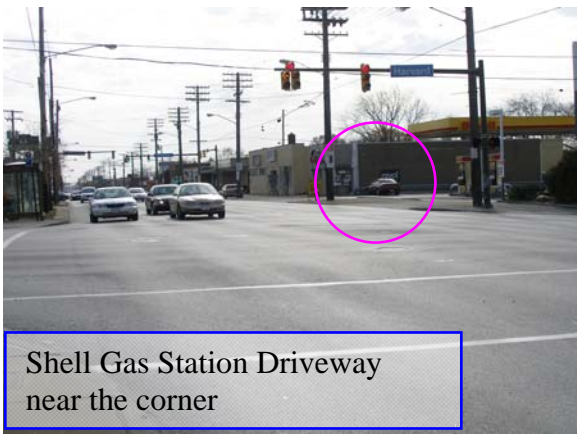
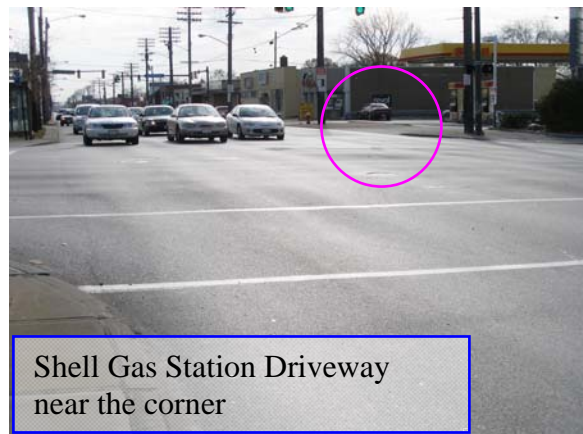
- The Shell gas station driveway, off of Lee Road, is too close to the corner of the intersection. Traffic entering the gas station through this driveway, especially when deciding to do so at the spur of the moment, forces trailing traffic to suddenly slow down and hence causes or creates the potential for rear end crashes. Traffic entering the gas station at this driveway comes mainly from two traffic streams. One stream is from Harvard Avenue westbound turning left onto Lee Road southbound. The other is through traffic from Lee Road southbound.

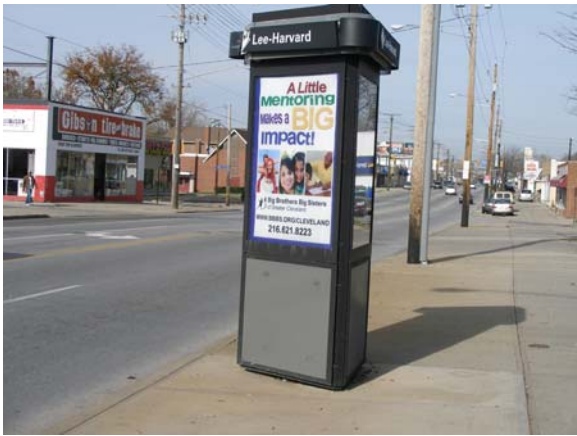
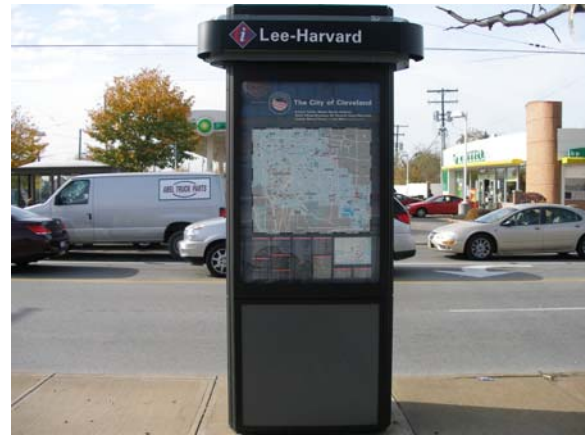
- Objects or structures situated too closely to the side of the road present an obstruction in the lateral clearance area. These objects or structures should be set back further from the edge of the roadways so as not to pose a real or perceived obstruction. The photos below show how close this information or poster kiosk is to the side of the road, causing trucks or larger vehicles to veer away from it, especially if they have protruding mirrors. This problem is exacerbated when the travel lanes are also narrow or have sub-standard widths.

- Lateral clearance is a matter that often times is overlooked. Clutter, and objects situated too closely to the curbs affect the perception of safety. Larger vehicles or drivers that shy away from being too close to adjacent curbside fixtures tend to move away and distance their vehicles from such objects or fixture, thereby driving closer to the lane divider markings. This movement, sub-conscious as it may be, leaves little room for vehicles in the inner or adjacent lanes to move freely. Therefore, the slightest reaction to a real or perceived need for avoidance causes or increases the potential for opposite direction or passing sideswipe collisions. An inventory and review of existing objects and fixtures located near the curbs should be made, and a plan of action to set them back as far away from the curbs as possible should be established in order to increase the area of lateral clearance.

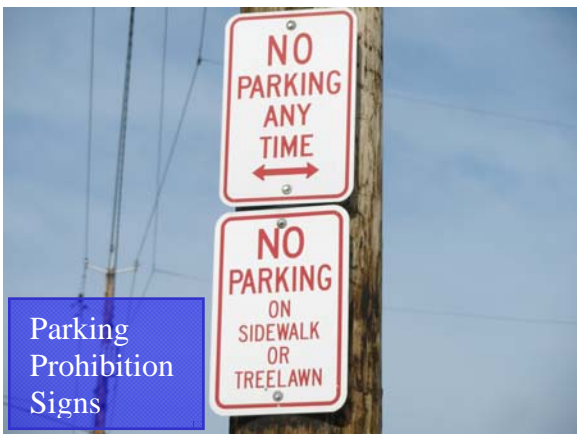
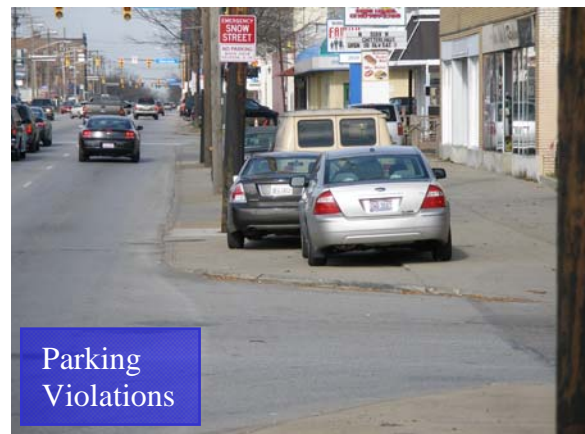
- The ‘No Parking on Sidewalk or Tree Lawn’ signs appear to be ignored, as vehicles are obviously parked on the sidewalk. While there may be no discernible correlation between crashes and parking on sidewalks and tree lawns, recording this observation as part of the audit was considered appropriate as it may affect pedestrian safety.

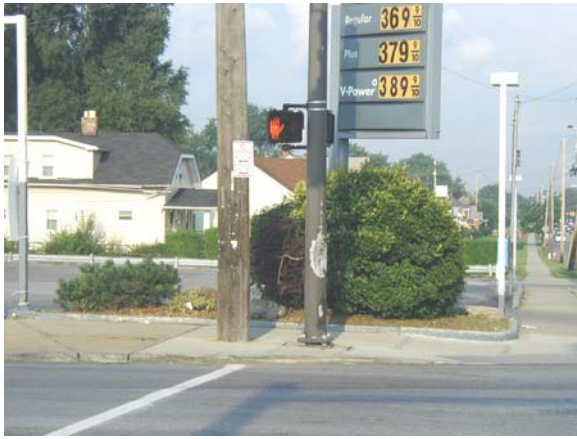
- In the southwest quadrant, within the premises of the Shell gas station, the shrubbery present is a problem to the line of sight. In that same quadrant, within the public right of way, physical obstructions, such as the traffic control signal pole and the light pole, present a more constrictive environment that makes it difficult for right turning traffic movements. The sharp curvature at that same corner makes it difficult for larger or longer vehicles, such as trucks, to negotiate the turns easily. Collision between turning vehicles and these obstructions, evidenced by the physical damage to the traffic control signal pole, indicates that increasing the turning radius, setting back the poles, and removing outgrown shrubberies would help reduce the potential for such mishaps.

Sharp curvature, and objects within the lateral clearance area

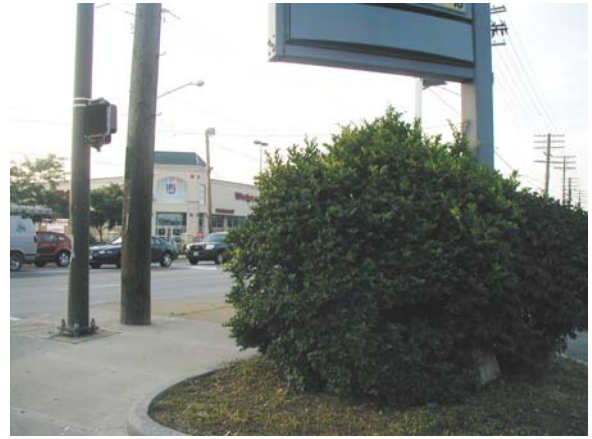
Unightly, overgrown, and excessively tall shrub

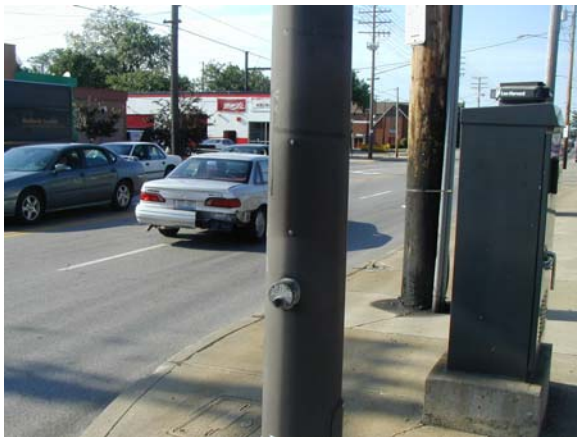
- The pedestrian crossing phase appears inadequate. The pedestrian crossing interval, for example, for crossing Lee Road was measured to be 7 seconds. A review of current pedestrian movements and consultation of the ITE guidelines are suggested. Missing pedestrian crossing actuation buttons and crossing orientation signs call for attention to providing these auxiliary equipments.

Missing pedestrian crossing actuation button and crossing orientation signs

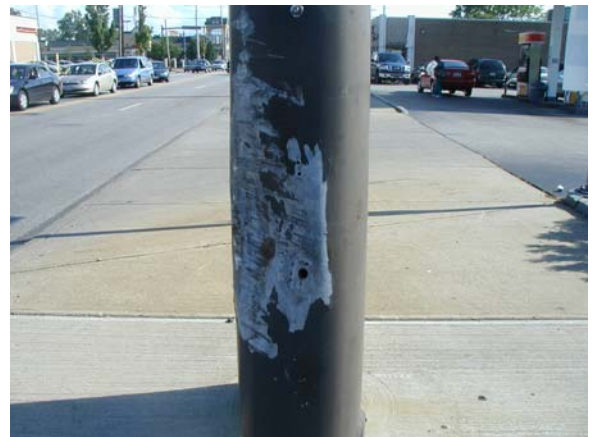
Damage to poles due to collision with turning vehicles

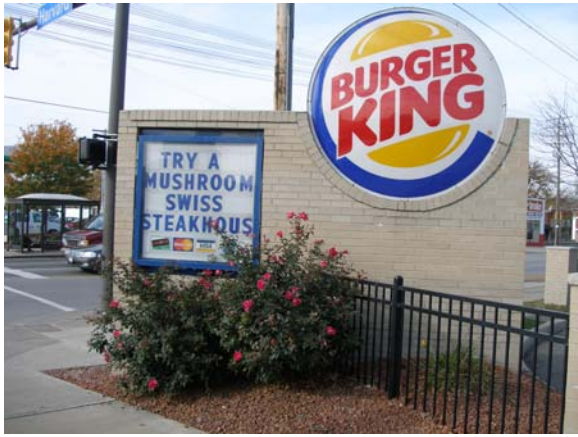
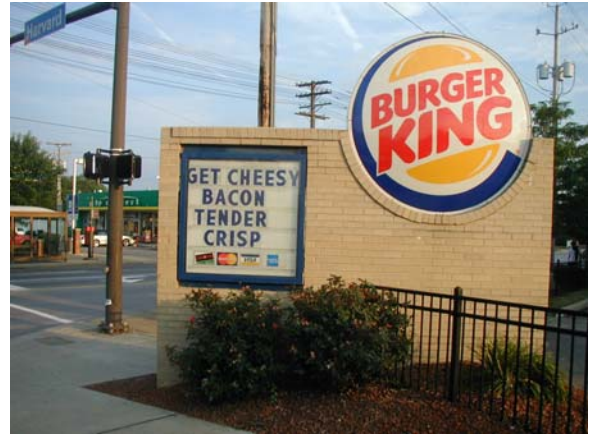
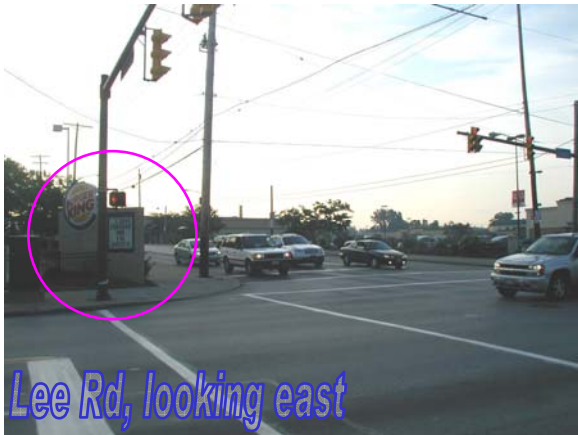
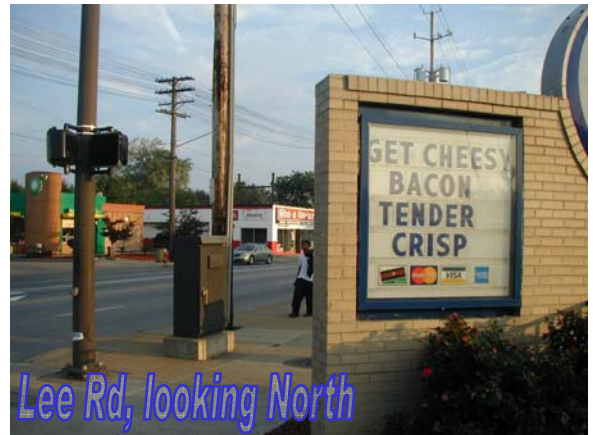
- This brick wall, within the northeast quadrant of the intersection, is too high and overly close to the curb and sidewalk of the intersection. It presents an obstruction to the line of sight, by both being situated too closely to the intersection and by being more than the customary 36 inches tall in order to be below the height of driver's eye.

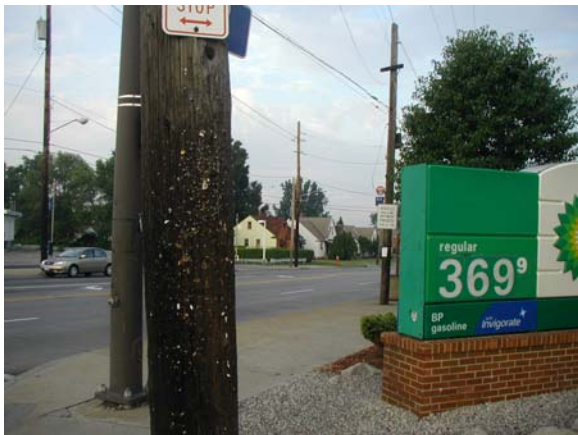
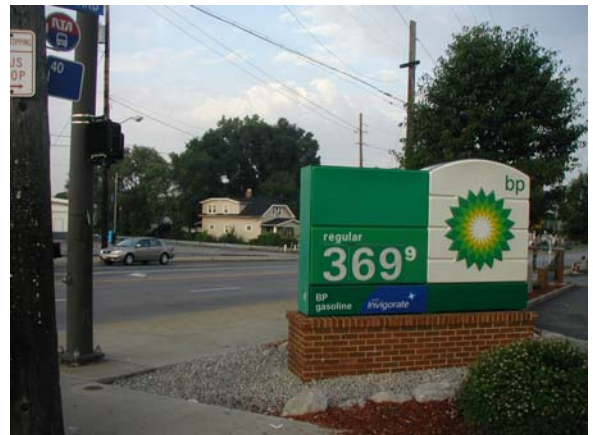
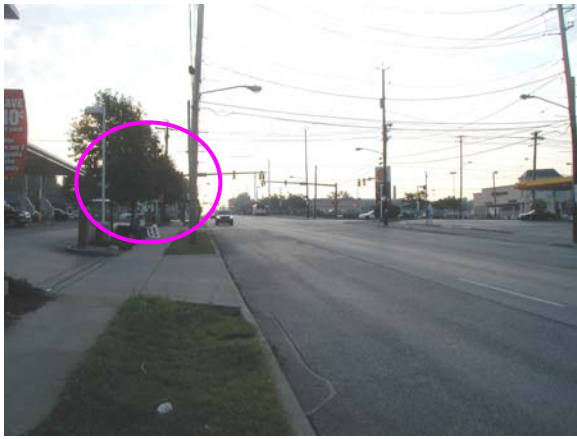
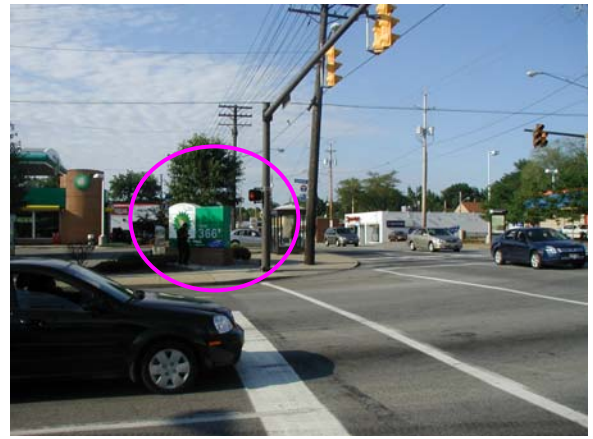
- This structure, within the northwest quadrant of the intersection, is rather high and is close to the curb and sidewalk of the intersection. It presents an obstruction to the line of sight, by both being situated too closely to the intersection and its height more than the customary acceptable 36” maximum in order to be below the height of the driver’s eye specified by AASHTO manual “A Policy on Geometric Design of Highways and Streets”.

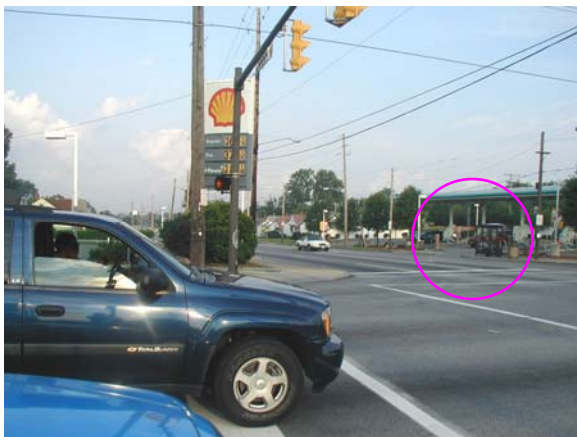
- There are two driveways for the BP gas station to and from Harvard Avenue. The first driveway is supposed to be a right-in, right-out driveway equipped with a small island to regulate such movement. The island is rather small, and the lanes demarcated by the island are too narrow. The island is most likely not clearly visible, especially at night. Tire marks on the island and chipping due to collision between the underside of vehicles and the island indicate infringement on the raised island. The driveway and the island within it should be widened, enlarged, and designed better for more visibility and less damage to vehicles and island.

The location of the 1st driveway of the BP gas station on Harvard Avenue, and how close it is to the corner of the intersection

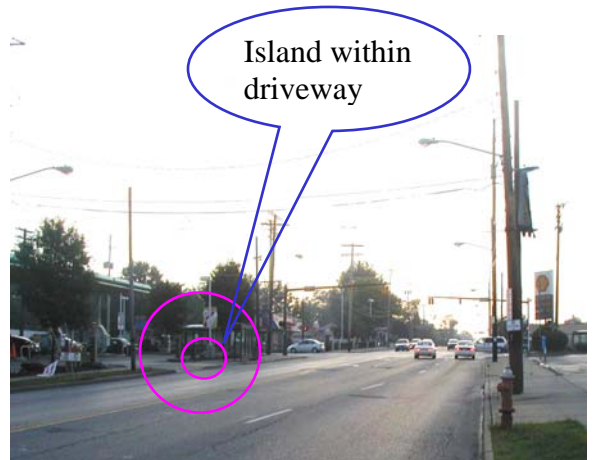
The 1st driveway of the BP gas station, on Harvard Avenue, showing an island designed for right-in/right-out only traffic movements. See next photograph.

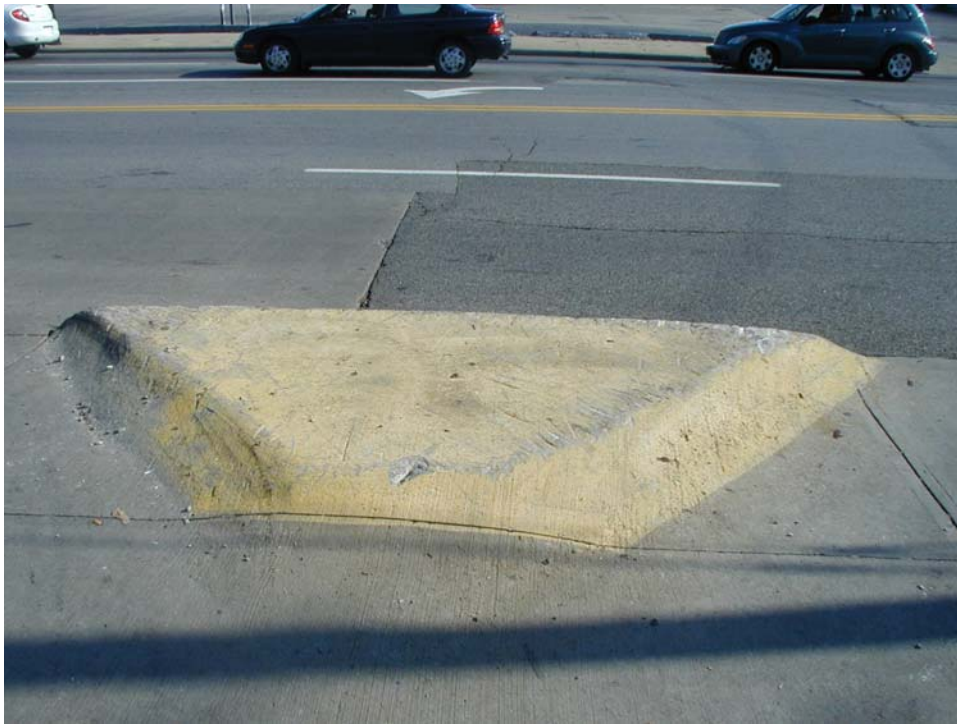
Raised island within the driveway of the BP gas station fronting Harvard Avenue to regulate right-in/right-out traffic movements

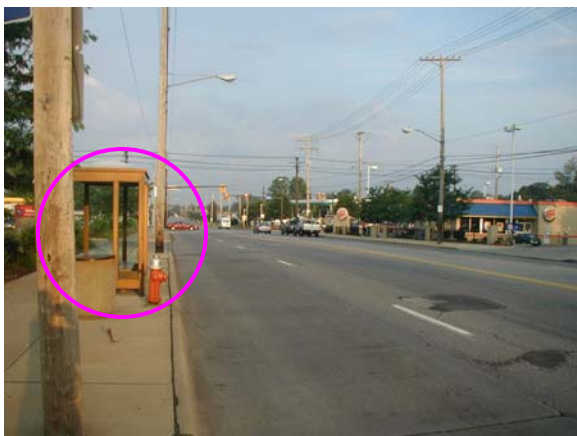
- This bus stop on Harvard Avenue, serving eastbound buses, is located at a reasonable distance east of Lee Road. The location opposite from it, on the other side of Harvard Avenue westbound would be a much better location for a bus stop and shelter to serve westbound buses instead of that located in front of the BP gas station at short distance west of Lee Road, or within feet of the intersection. When buses stop at that location, through traffic either gets trapped behind them or drivers attempt to avoid them, to get out of that trap, by abruptly maneuvering to the left, which increases the potential for sideswipe collisions.

Bus stop and shelter on Harvard Avenue, eastbound, satisfactorily located at a reasonable distance east of Lee Road

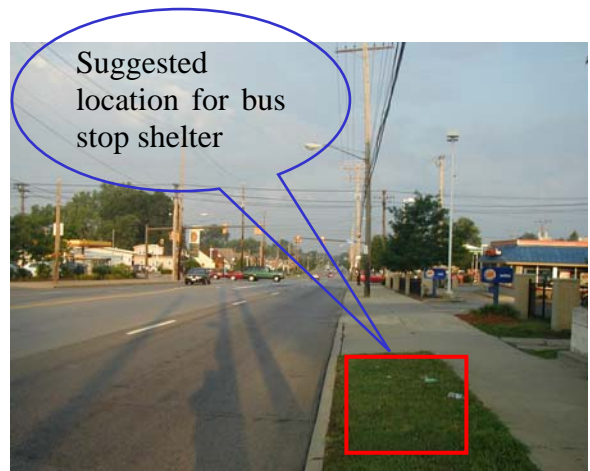
Suggested location for a bus stop and shelter on Harvard Avenue for westbound buses, opposite that on the other side

- The bus stop in front of the BP gas station, west of Lee Road, is too close to the intersection. Traffic trailing westbound buses that stop at the bus stop to drop off or pick up passengers gets trapped behind these buses and the flow of through traffic to their left. This causes erratic behaviors by drivers behind the buses. Drivers make sudden lane changes to avoid being stopped or trapped behind a bus. These maneuvers increase the potential for sideswipe collisions. This bus stop would be better suited if moved upstream of the intersection and located opposite that on Harvard Avenue which serves eastbound buses. The bus stop could also be equipped with a bus shelter, as one does not presently exist, which would be consistent with what is presently available across the street on Harvard Avenue.

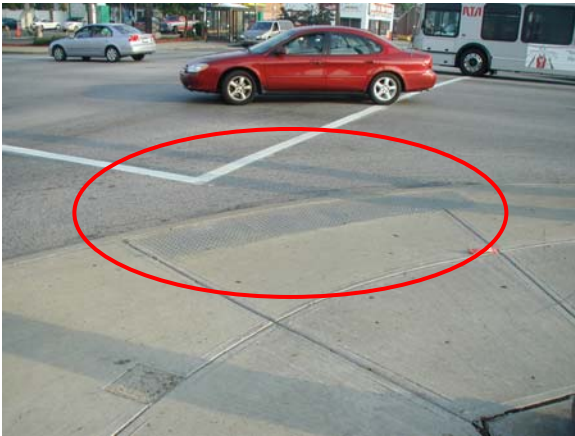
- The sidewalks and pedestrian ramps seem to have been recently refurbished. Truncated domes for the blind and ramps for the disabled have been incorporated in the new reconstruction.

Truncated Domes on freshly laid concrete
