# **NOACA Technical Memorandum**

## **Signal Warrant Analysis City of Bay Village US 6 (Lake Road) and Bradley Road**

February 2018

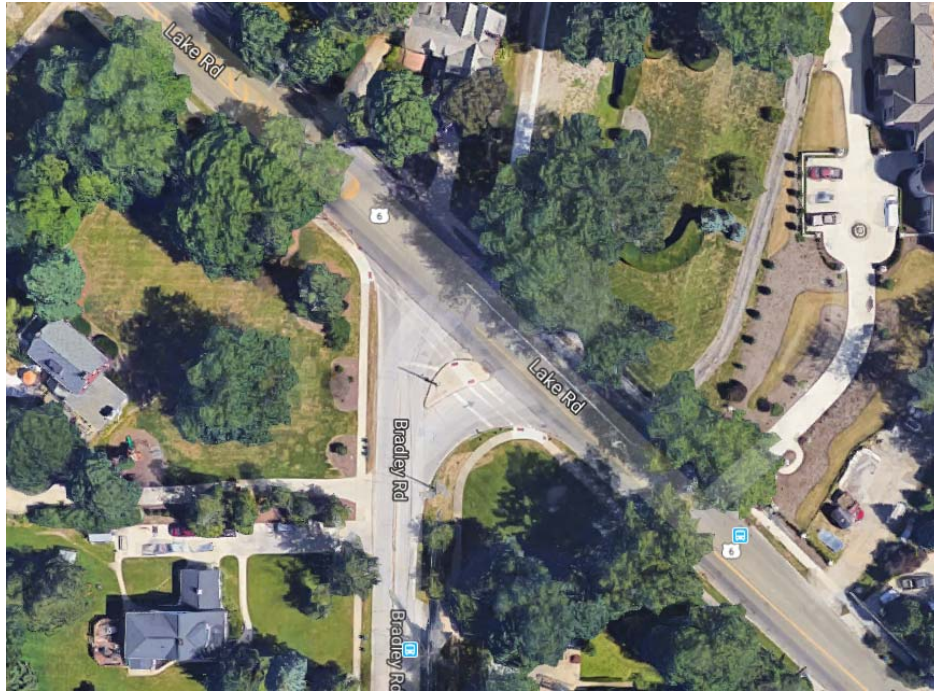
**Image 2: Aerial View of Project Location**

Lake Road, which travels roughly east-west through the study area, is considered the “major” road in the analysis due to its higher functional classification as a principal arterial (FC3) and higher traffic volumes. The posted speed limit is 35 mph with one lane in each direction. Bradley Road is classified as a major collector (FC5) and carries a posted speed limit of 35 mph, with one lane in each direction north-south. Because Lake Road is the major road, it is not controlled by any traffic-control device, while Bradley Road is controlled by “STOP” signs. It is noted that the northbound approach of Bradley includes a small channelizing island, or “pork chop,” due to the heavy skew of the approach. The channelizing island allows the northbound approach to function effectively as a two-lane approach, with a short left-turn slot capable of storing two or three passenger vehicles without blocking access to the right-turn lane to Lake Road.

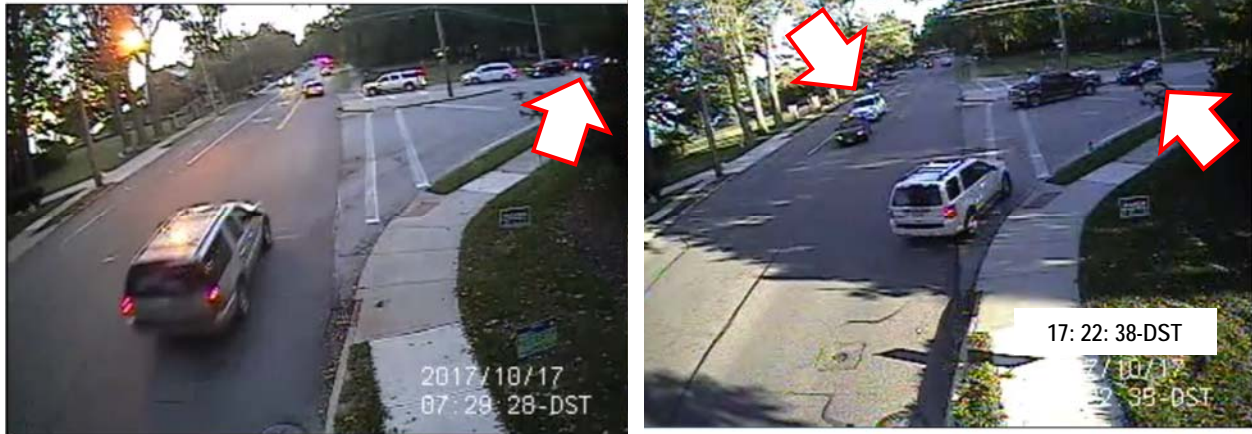
#### Images 4 and 5: Queuing Conditions on Bradley and Lake Roads

1. Relatively heavy eastbound volumes make it difficult to find sufficient gaps to make a right turn (a concern usually in the AM peak).
2. Relatively heavy westbound volumes (including westbound left turns) make it difficult to find adequate gaps to turn left (a concern usually in the PM peak).

These two conditions are presented in screen captures in the figure below, with the worst observed queuing conditions highlighted by red and white arrows.

NOACA staff reviewed the video of traffic movements used to extract turning movement count data, concluding that the primary operational problems by Bradley Road users fall into two categories:
