ROADWAY PAVEMENT MAINTENANCE REPORT

2020

VILLAGE OF KIRTLAND HILLS

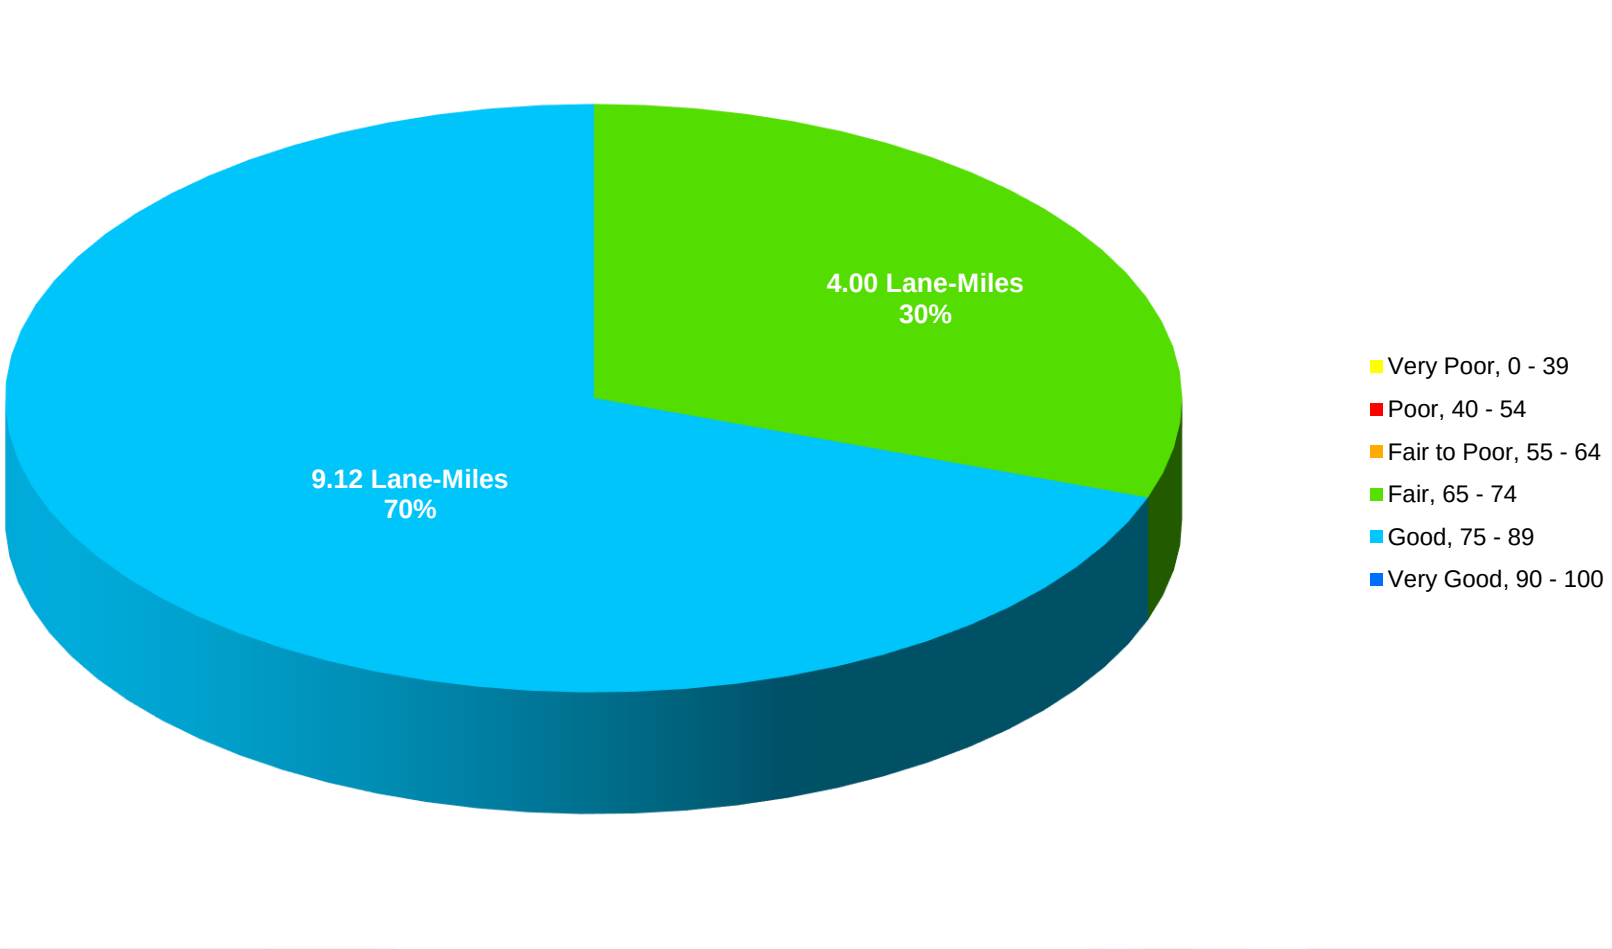
Figure 3: 2020 Kirtland Hills Pavement Network Condition Chart by Lane-Miles

As indicated, about 70 percent of the lane-miles pavement are currently in the “Good” condition and the lane-miles weighted average PCR also represents a “Good” condition. The rest of the lane-miles are in the “Fair” status and demand some kind of preventive maintenance treatments.

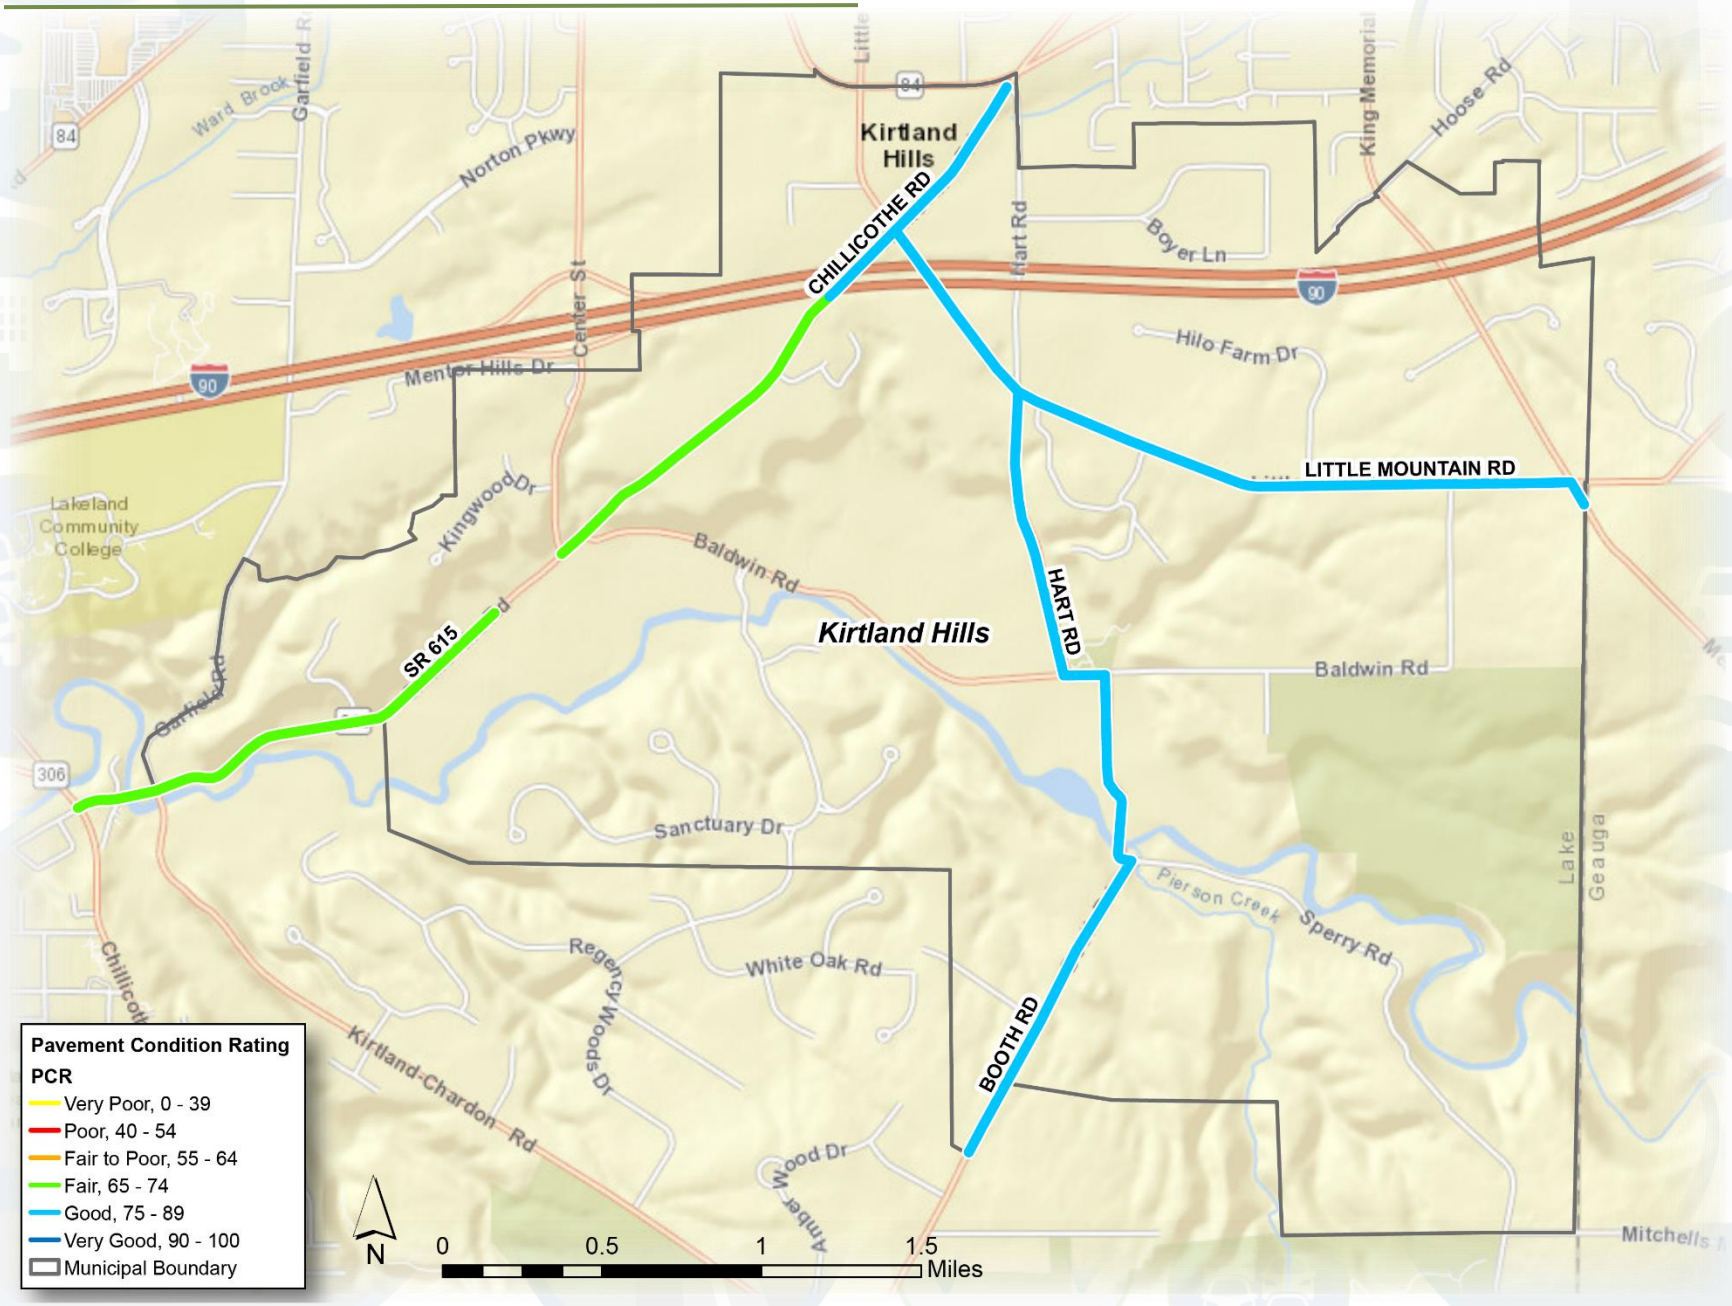
Map 2: 2020 Village of Kirtland Hills Pavement Condition

Map 2 illustrates the 2020 Kirtland Hills roadway pavement condition for each segment record and Table 3 tabulates the 2020 Kirtland Hills pavement condition listing.
