Road Safety Audit

**SR 306 (Reynolds Road)
and
US 20 (Mentor Avenue)
Intersection
City of Mentor, Ohio**

May 2009

**Prepared By
Northeast Ohio Areawide
Coordinating Agency
1299 Superior Avenue
Cleveland Ohio 44114**

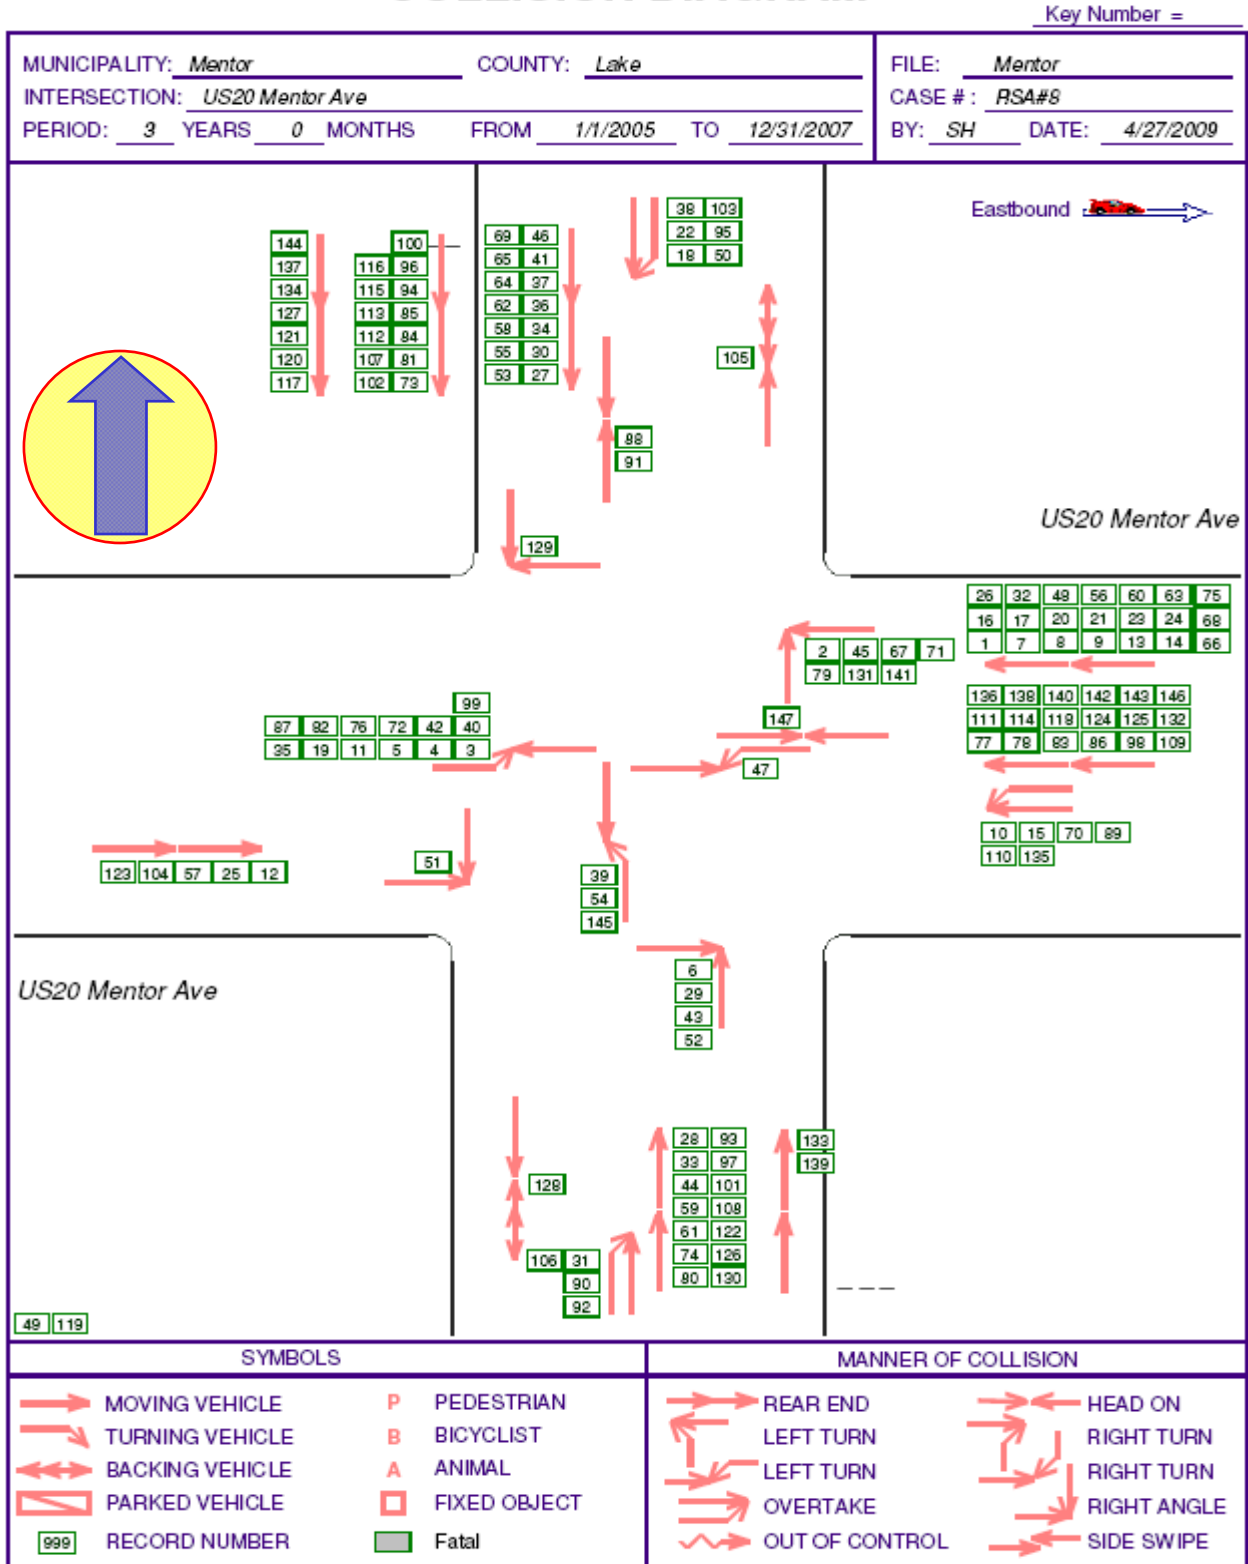
COLLISION DIAGRAM

This collision diagram depicts the type, frequency, and relative location of the crashes that occurred in the most recent 3-year period of the crash data (Year 2005-2007). It is intended to aid the reader to understand, by viewing, the nature of the crash problems at this intersection.

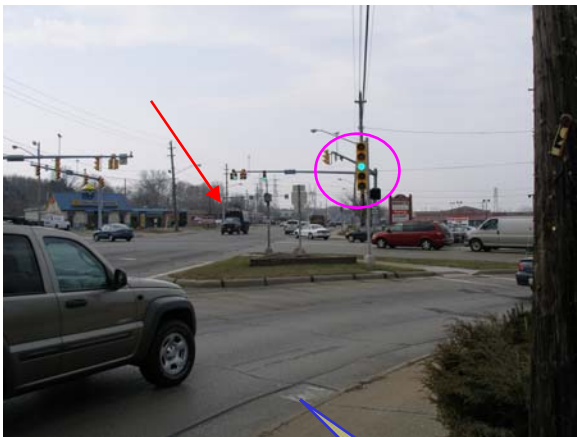
2. Pedestrians are often unseen well in advance of approaching right turning vehicles due to the presence of overgrown, tall shrubs. Although the pedestrian signal can be controlled by pedestrians, right turning traffic advances beyond the faded stop line in this lane, which is also too far from the main road, to make right turns on red;

Faded Stop Line

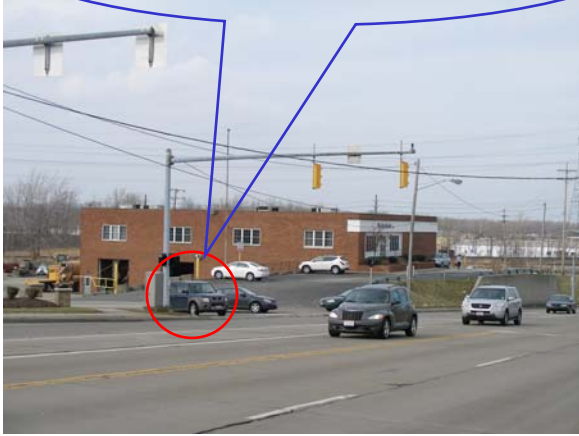
Driver line of sight in this vehicle is obstructed by the presence of vehicles to its left waiting in the left turn bay.

Vehicle blocks line of sight of driver in vehicle on right

- This shopping plaza driveway, fronting SR306, should be addressed based on the illustrations in the following photographs. Either prohibiting right turns on red or setting back the stop line for the left turn bay should help address the problem of the line of sight.

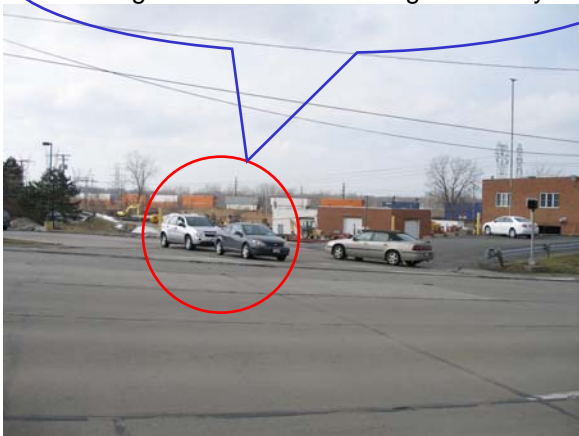
Retaining wall and embankment are irremovable obstacles to line of sight

Set back stop bar for this left turn bay to overcome problem of line of sight for vehicles in the right turn bay

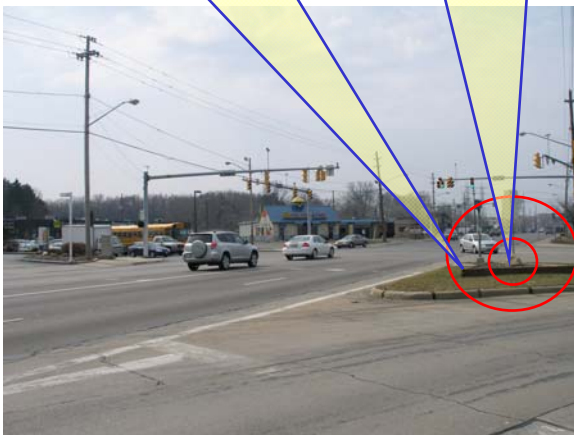
- The boulder and the raised landscape timber in the island are fixed objects that are neither necessary nor aesthetically pleasing and pose a hazard.

Boulder: an unnecessary fixed object, unsightly

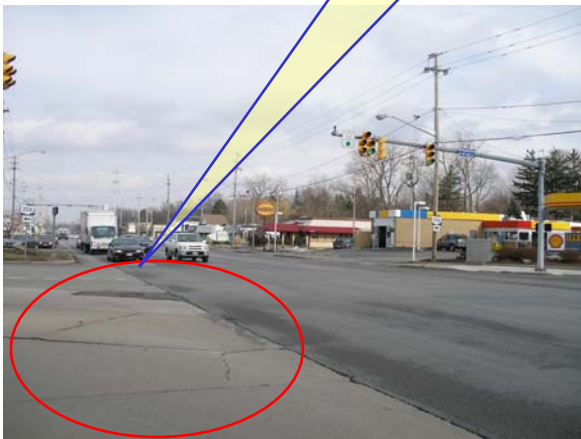
- Surface conditions are less than desirable. Cracked pavement and sidewalks, debris on pavement and sidewalks, and broken curbs were noticed.

Cracks in pavement

- Clean or pressure wash the roadway pavement and sidewalks from debris, and repair the surfaces of both pavement and sidewalks to provide for a smoother ride, safer conditions, more pleasant pedestrian experience, and a more aesthetically pleasing environment;

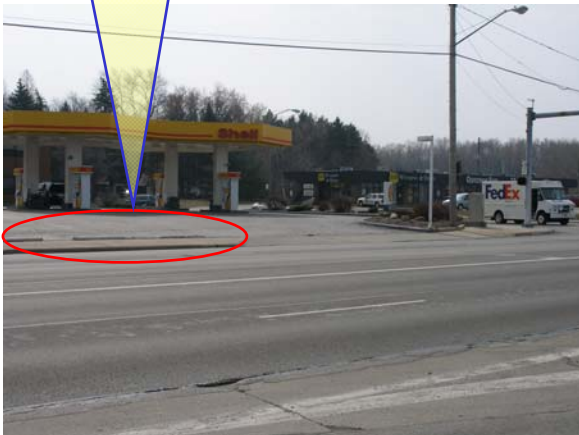
Proposed restricted Right only

Resize and realign the driveway of the car wash facility and restrict it to right turn only at least during peak periods.

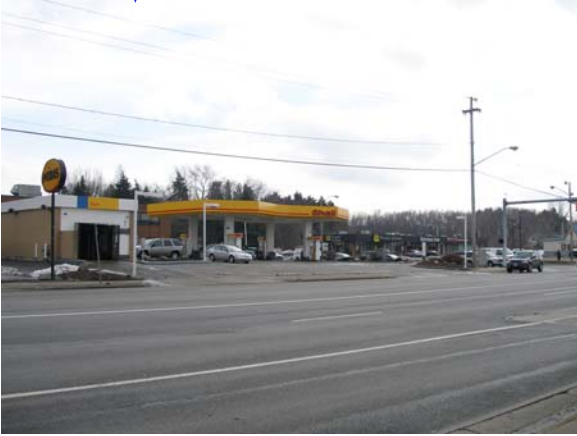
Misalignment of vehicle exit and entry points into gas station due to the misalignment of driveways with the positions and orientation of the gas pumps.

- Consolidate the driveways for the Shell gas station fronting US20. Move the driveway closest to the corner of the intersection a little farther east. Open a curb cut for it and close the existing one. Narrow the driveway for the car wash building and restrict it to right turn only, either at all times or at least during peak periods.

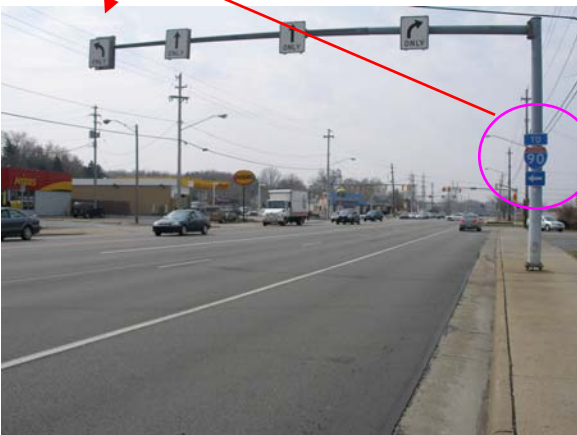
- Signage to I-90 is inconspicuous and small. It is placed on the mast pole on the far right of the roadway, but potential users need to see it well in advance and expect to find it placed overhead as traffic bound for I-90 will be or should be advised in advance to be in the left lane. Using guide signs specified in the Ohio Manual of Traffic Control Devices (OMUTCD) would be helpful to Mall shoppers and visitors who may not be familiar with area.

Sign pointing to I-90 is placed too far to the right and may not always be seen by drivers, especially when trucks or tall vehicles occupy the channelized right turn lane.

Place the I-90 information sign overhead on mast.
